BEFORE THE NEBRASKA DEPARTMENT OF ENVIRONMENT AND ENERGY

IN THE MATTER OF)	
AltEn, LLC,)	CASE NO. 3546
)	
FID # 84069)	EMERGENCY COMPLAINT
)	AND ORDER
Respondent.)

ATTACHMENT I Photographs

Release of Thin Stillage and Cattle Manure from Digester at AltEn LLC, IIS #84069, RA
#021221-NH-0845

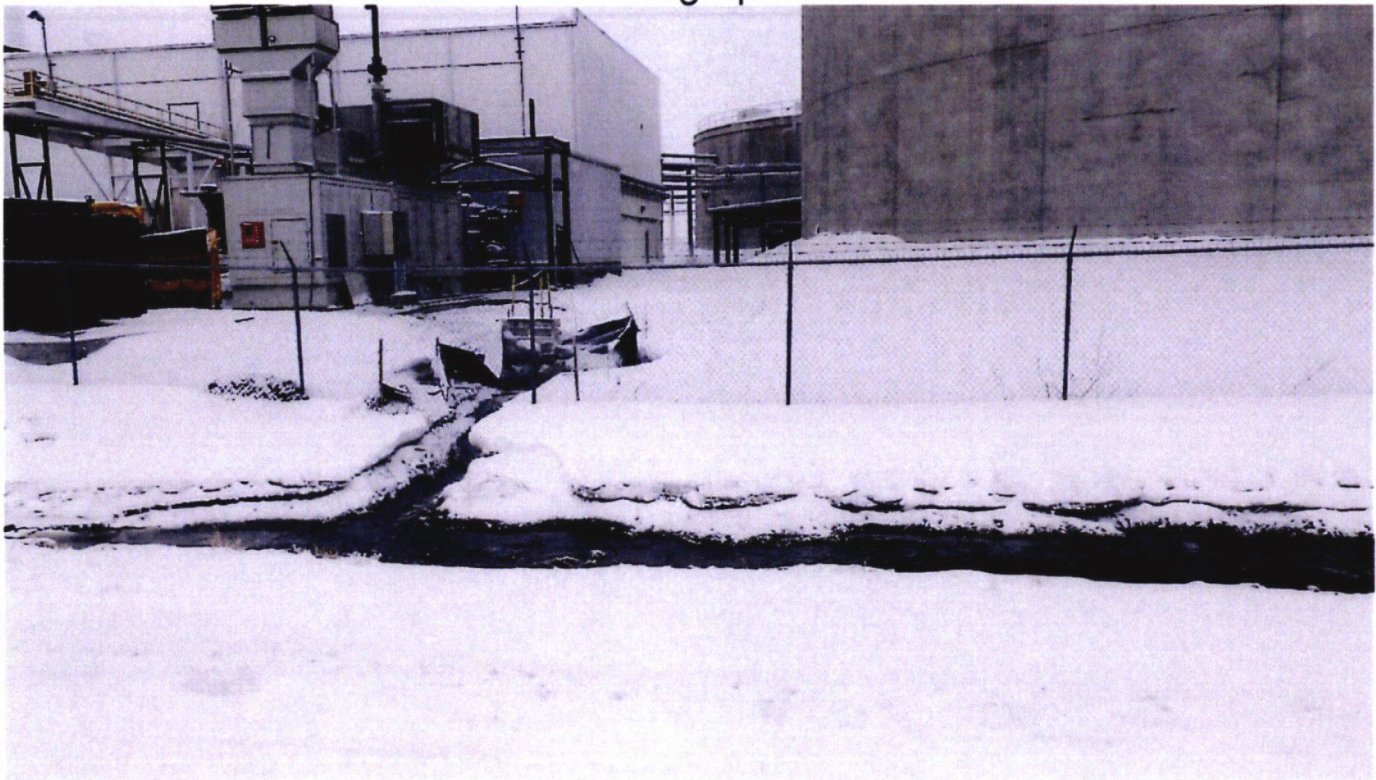
Photo 1

Mr. Peterson drove me to the digester. Upon arrival I observed wastewater conveying from the southwest side of the digester, photo 1. I asked Mr. Peterson if the break is located on the southwest side. Mr. Peterson stated no and drove to the southeast corner. There is heavy flow cascading over the hill into the adjacent ditch, photos 2 and 3. We then exited the truck and walked to the digester. The ruptured pipe is located on the east side splashing and spraying against the digester, photo 4. The surrounding area east, west and north are filled with wastewater, photos 5 and 6. I asked Mr. Peterson if the tank was full. Mr. Peterson confirmed the tank contained four million gallons. I asked what containment activities have been employed. Mr. Peterson stated the break is below ground. The water pressure and break area are making management difficult. Mr. Peterson stated they installed two trash pumps, photos 7 and 8.

Description: This photo depicts water flow from the storm water conveyance system. Water is entering the ditch flowing east along the south side of the digester.

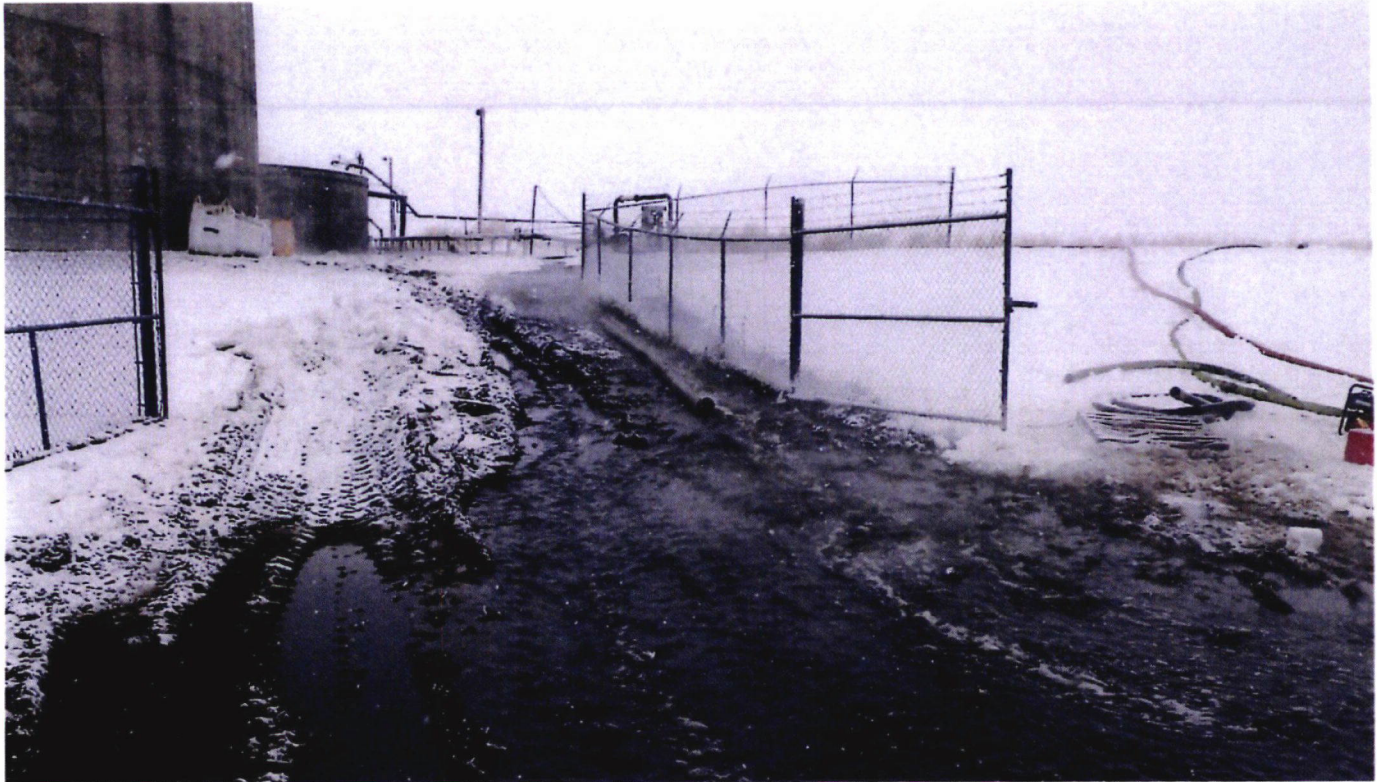
Photo 2

Description: This photo depicts cascading water exiting the southeast side of the digester.

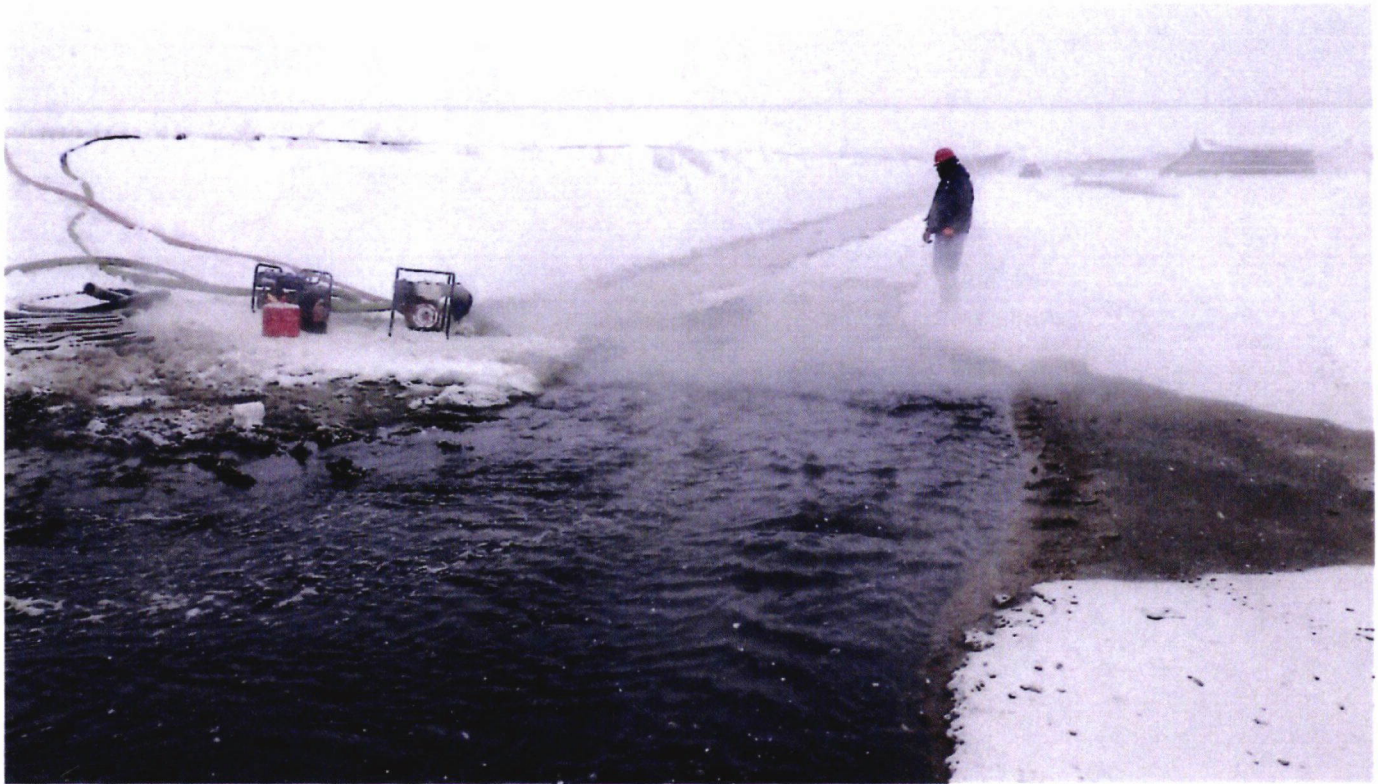
Photo 3

Description: This photo depicts water entering the ditch and flowing along the emergency lagoons. Also depicted is the trash pumps installed to transport water into the emergency lagoon.

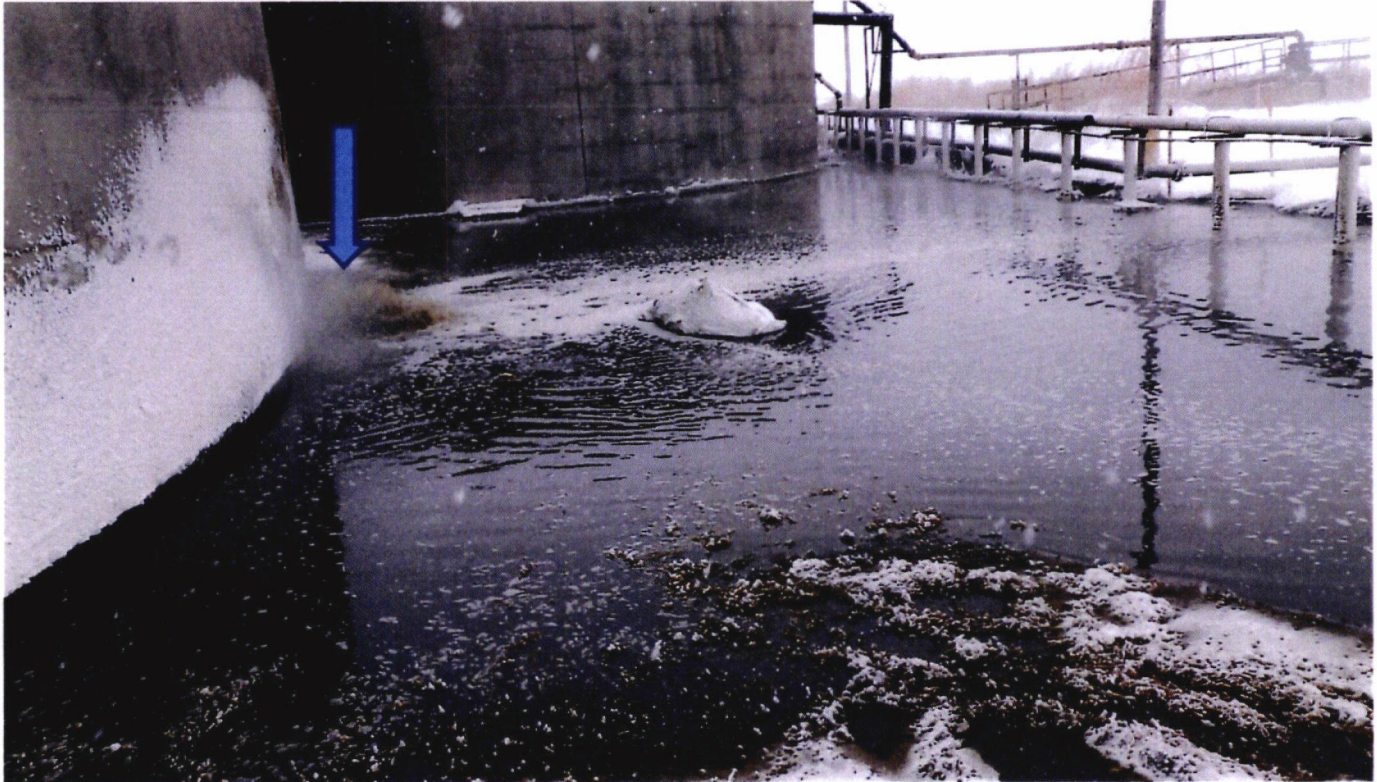
Photo 4

Description: This photo depicts the damaged area (arrow). Water is quickly exiting the digester creating ponding and discharge.

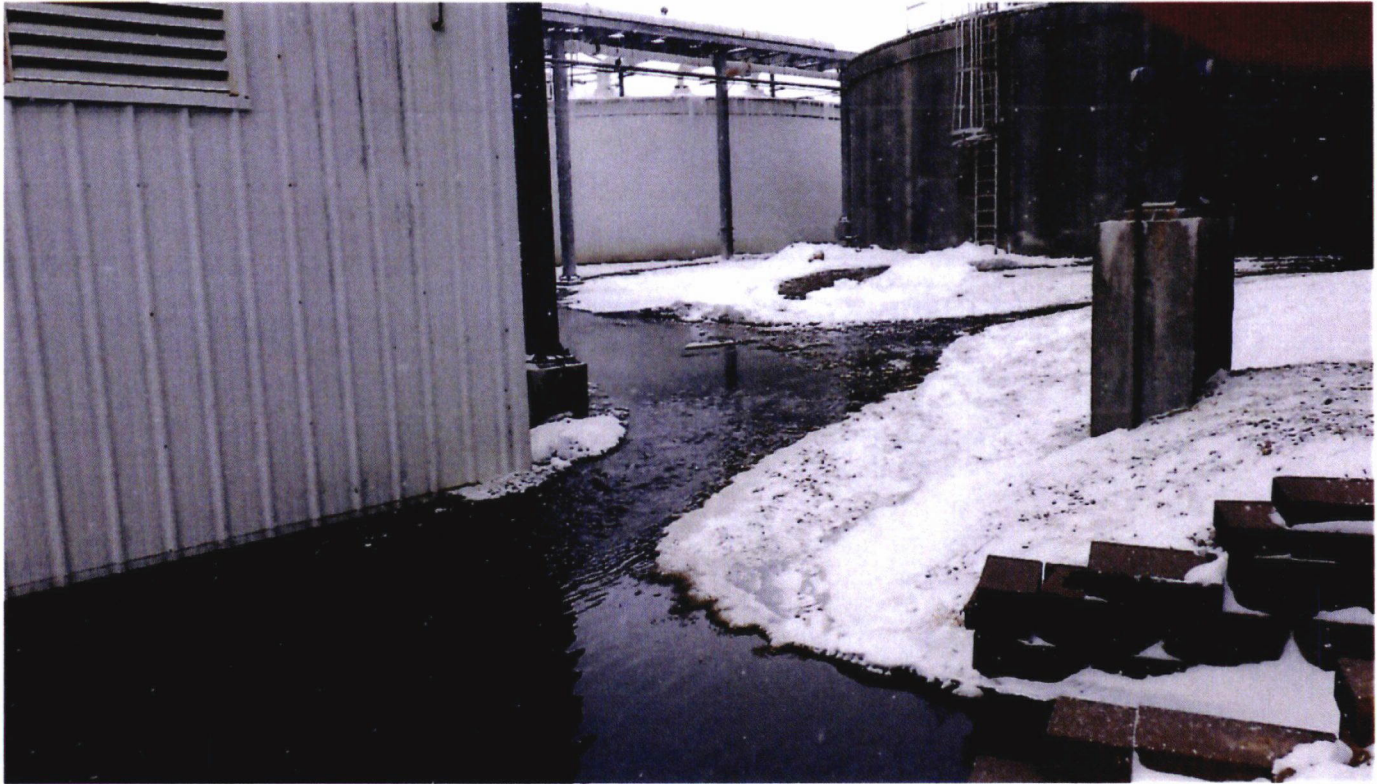
Photo 5

Description: This photo water flowing behind the digester. Wastewater is flowing behind the digester (arrow). Flow continued southwest and into the conveyance system depicted in photo 1.

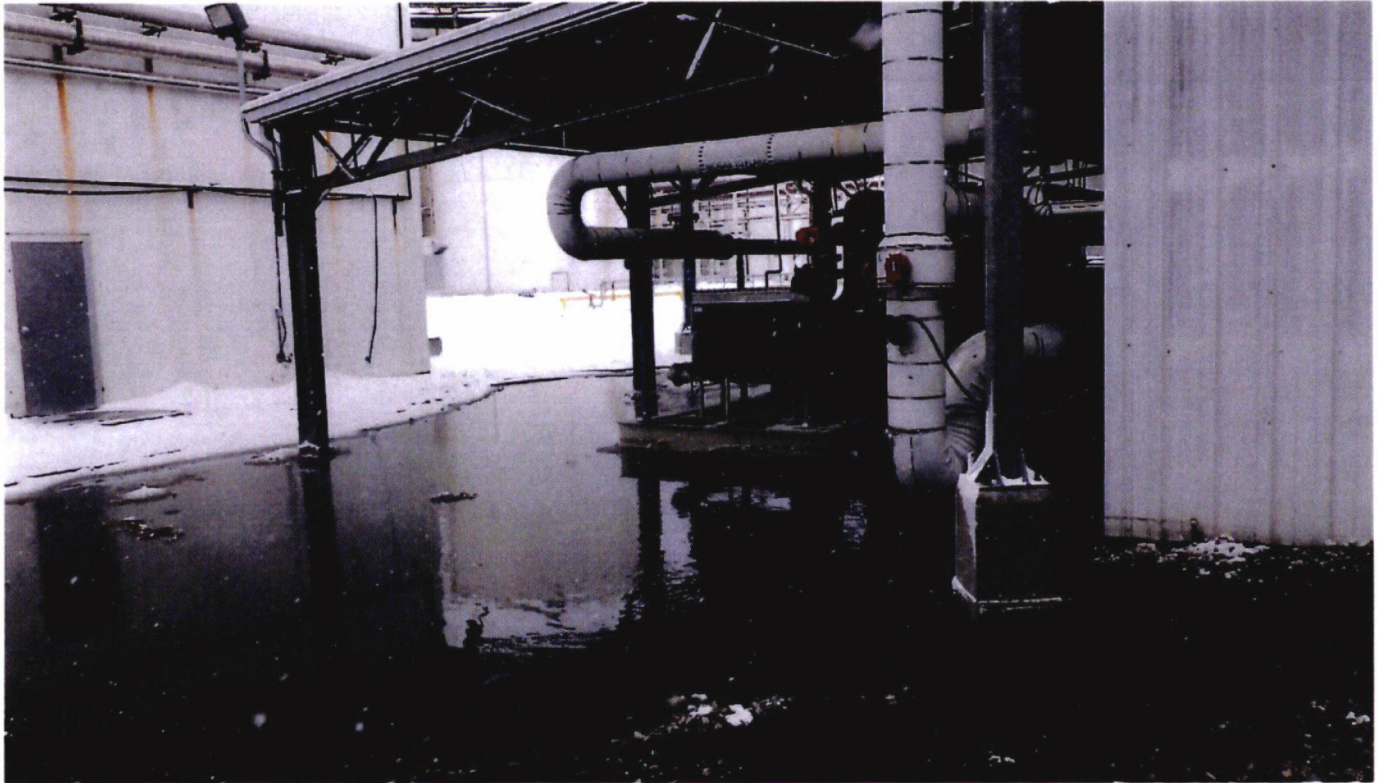
Photo 6

Description: This photo is pooled water west of the digester.

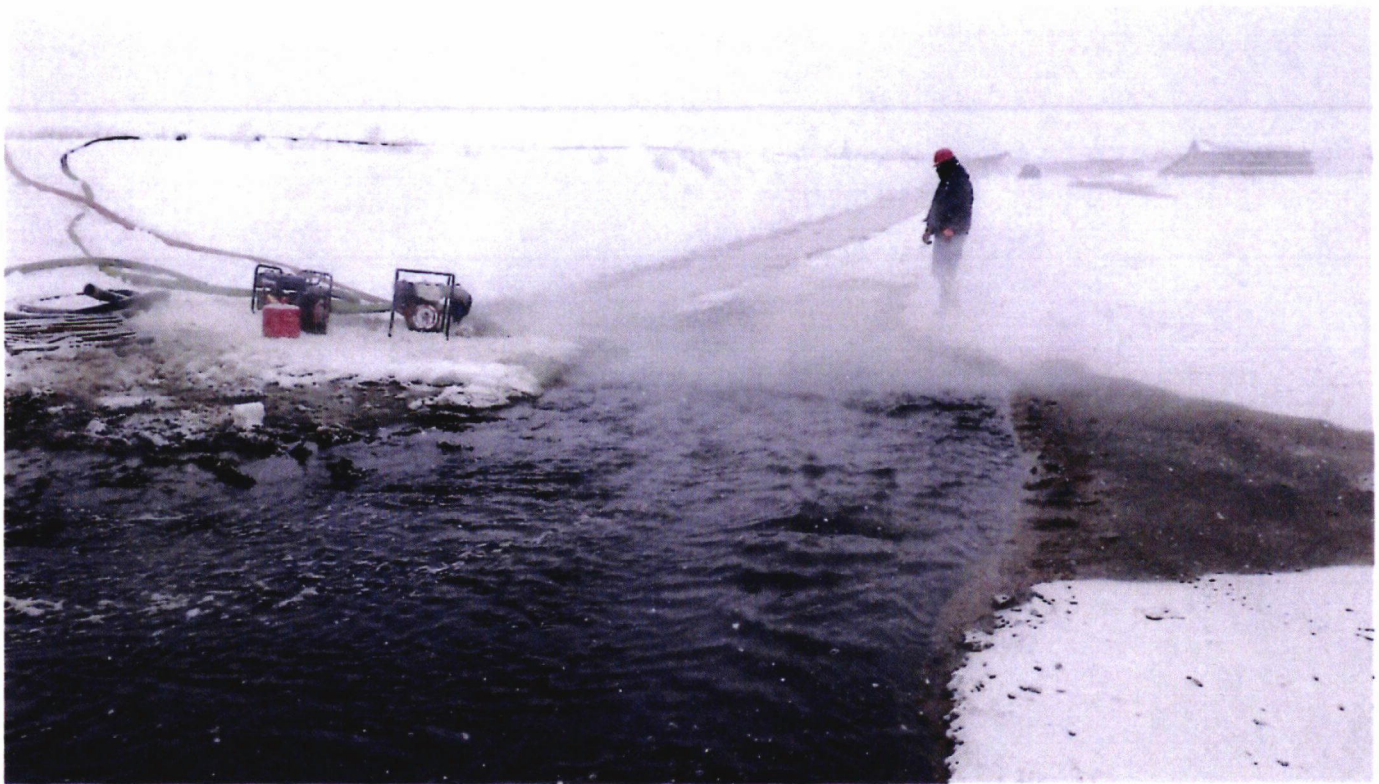
Photo 7

Description: This photo depicts the trash pumps used to transport water into the emergency lagoon.

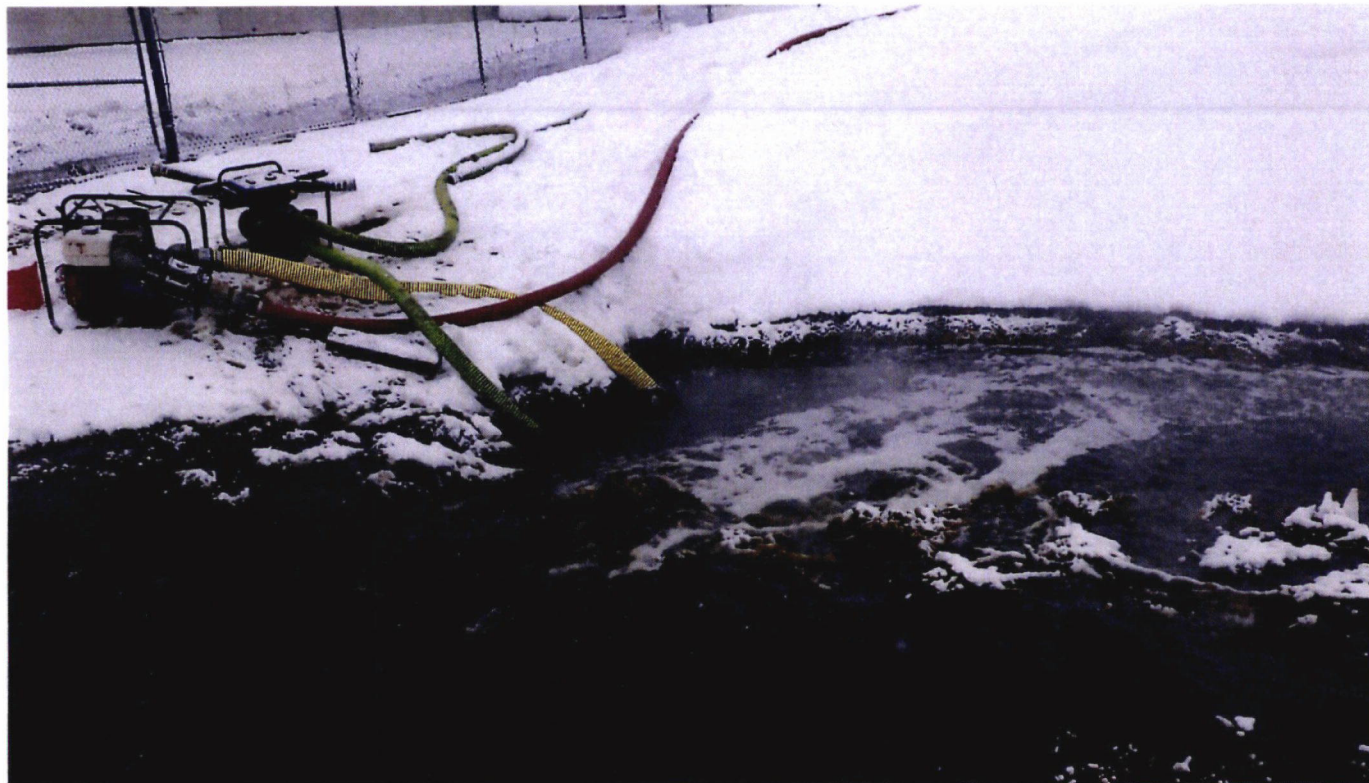
Photo 8

Description: This photo depicts the trash pumps used to transport water into the emergency lagoon.

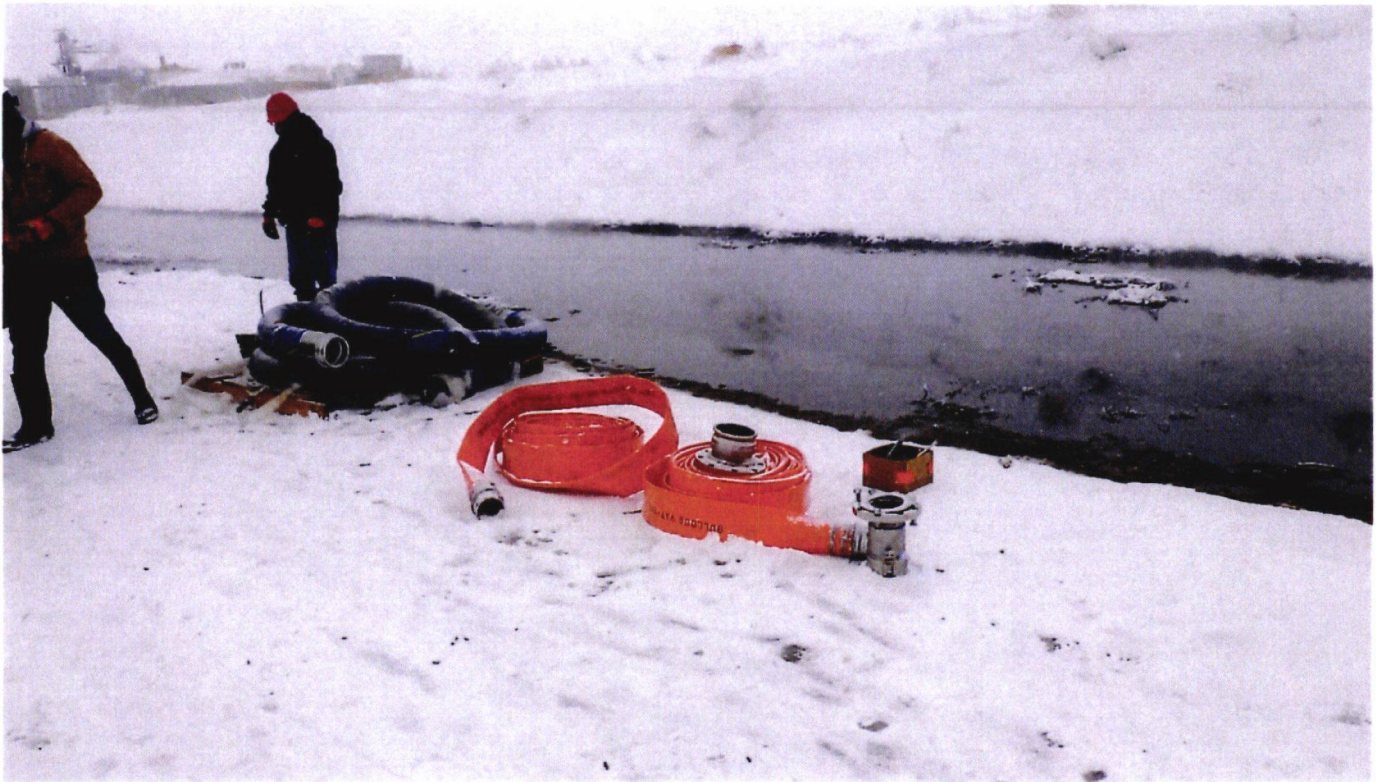
Photo 9

Description: This photo depicts AltEn personnel working to install an additional trash pump. The pump is being installed approximately 100 yards east of the pumps depicted in photo 8.

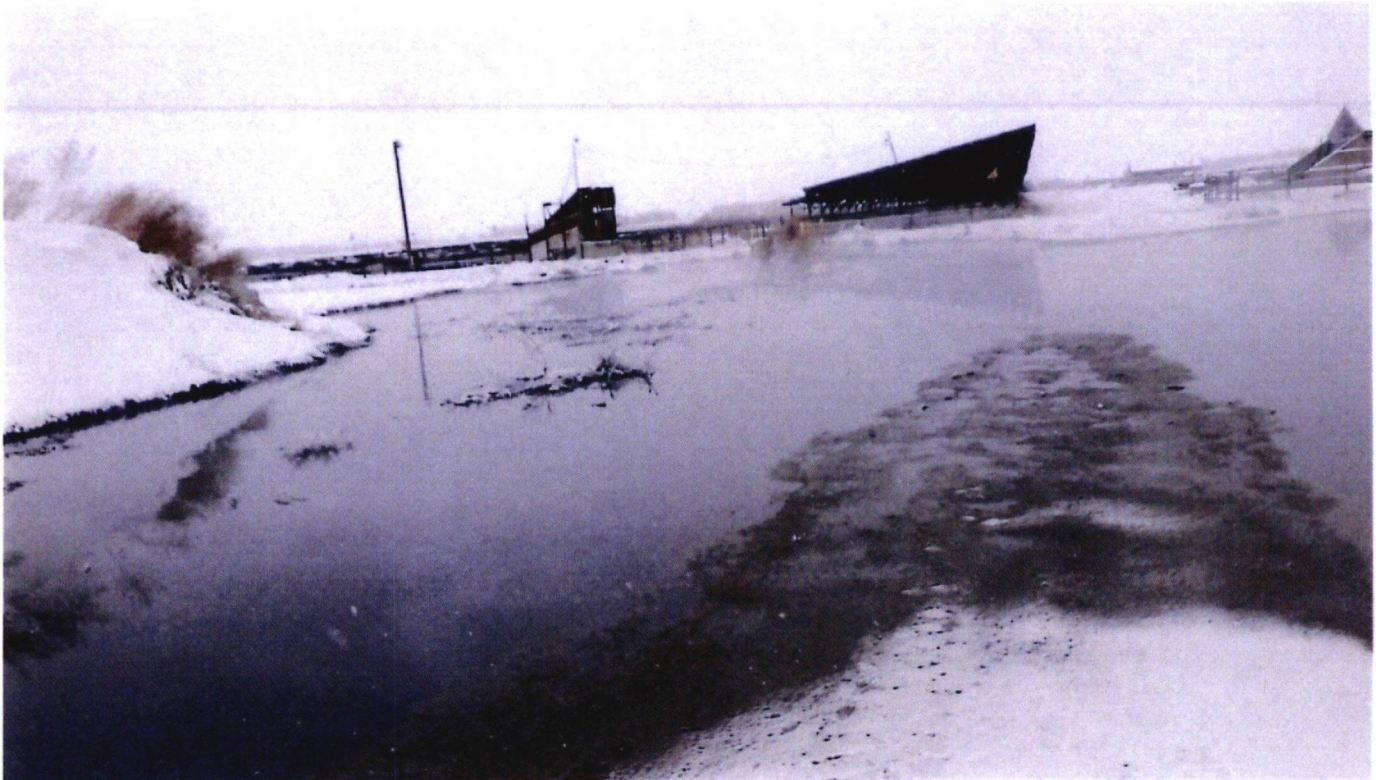
Photo 10

Description: This photo depicts the creek flooding the road entering Mead Cattle.

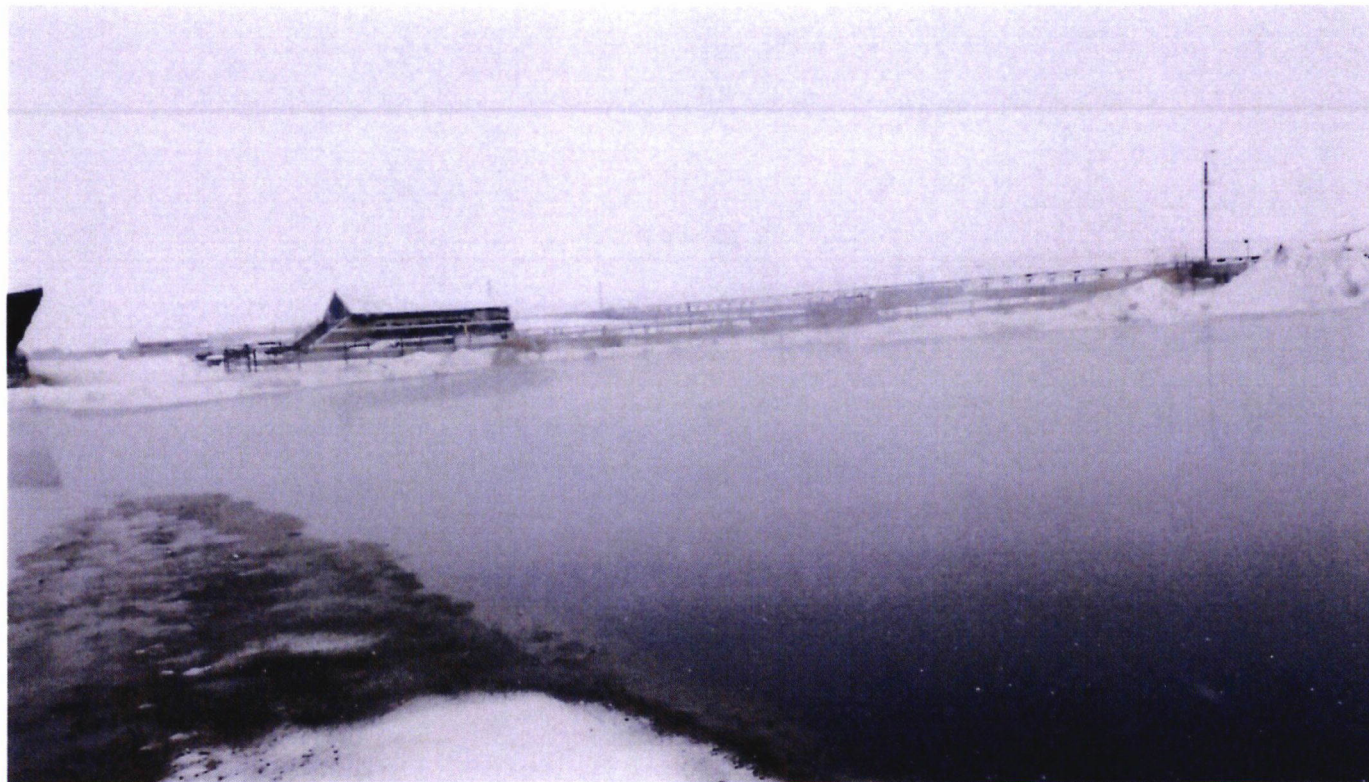
Photo 11

Description: This photo depicts water flooding the road and ponding on the south side.

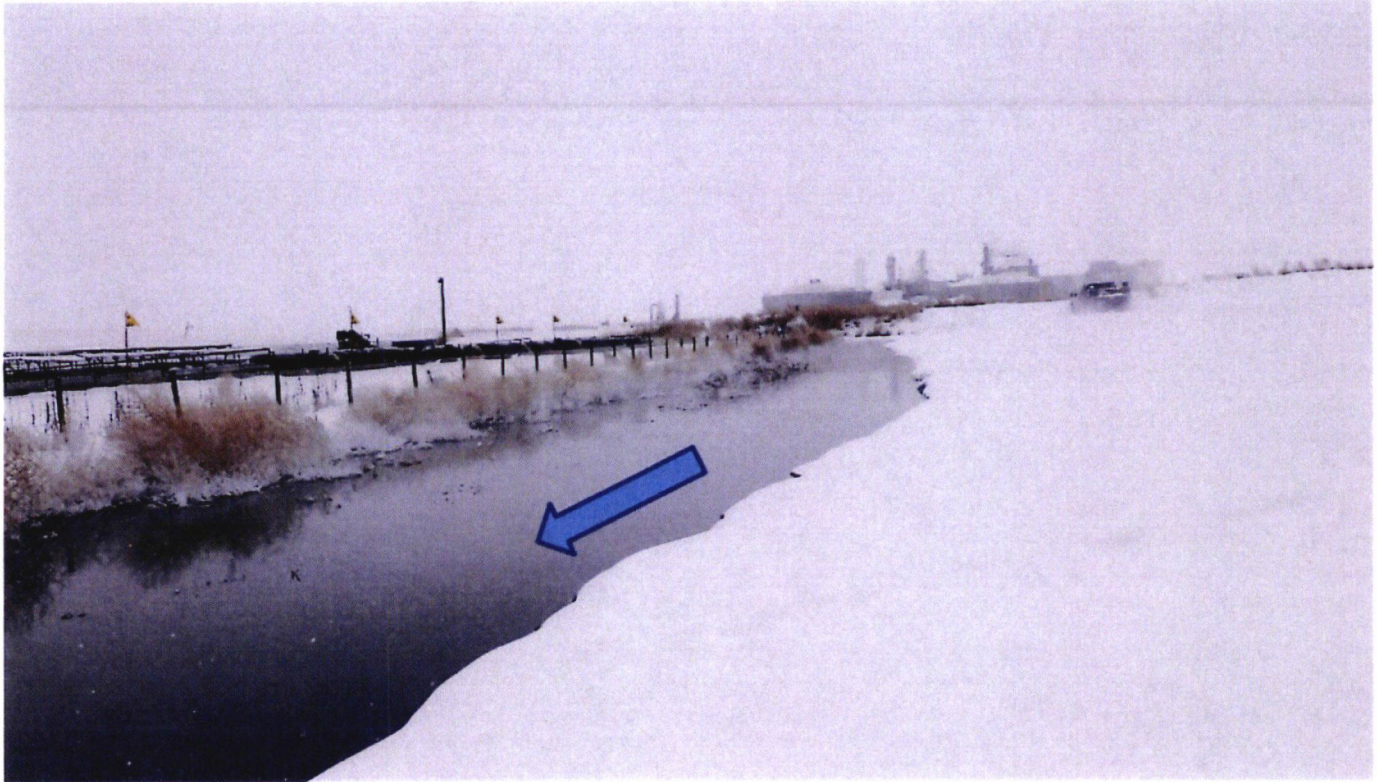
Photo 12

Description: This photo depicts wastewater flowing east along Mead Cattle. The arrow depicts flow direction.

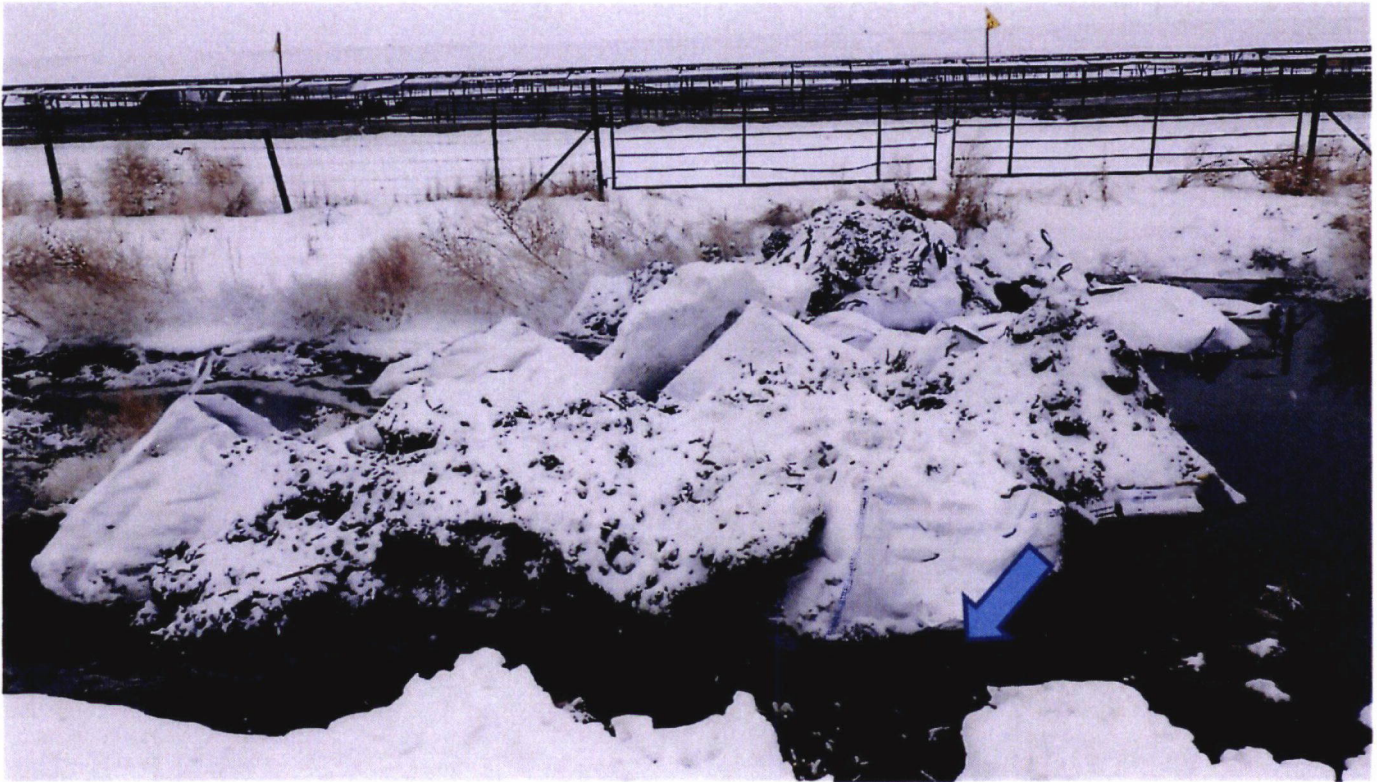
Photo 13

Description: This photo depicts a makeshift dam made of biochar supersacks. This photo also depicts the breach that occurred on the north side (arrow)

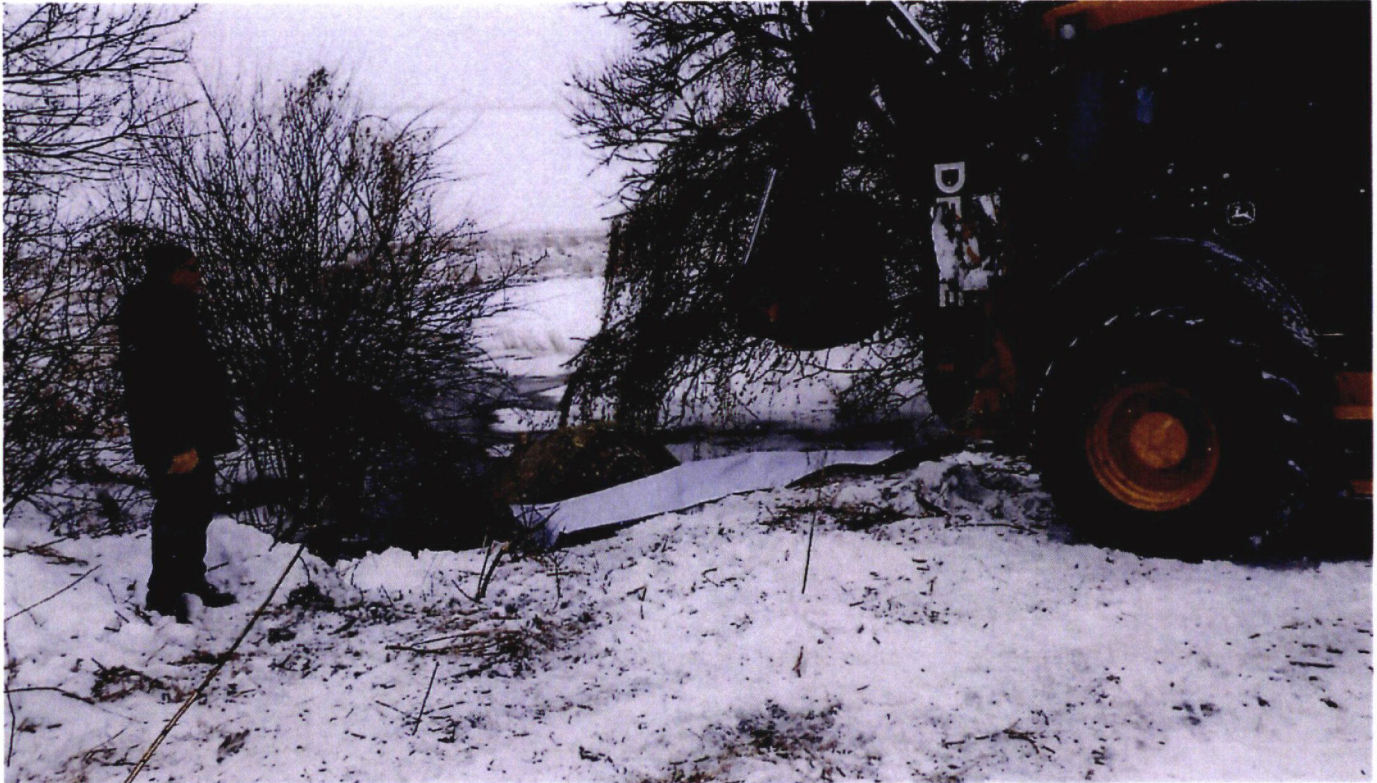
Photo 14

I then drove to the culvert that exits the facility. The culvert is located on the southeast side of the property. When I arrived, I met representatives from the University of Nebraska – Lincoln (UNL). I observed UNL installing plastic, bales and cement (rip-rap) in attempt to hold back the flow, photos 14 and 15.

Description: This photo depicts UNL personal installing plastic and bales to dam the culvert.

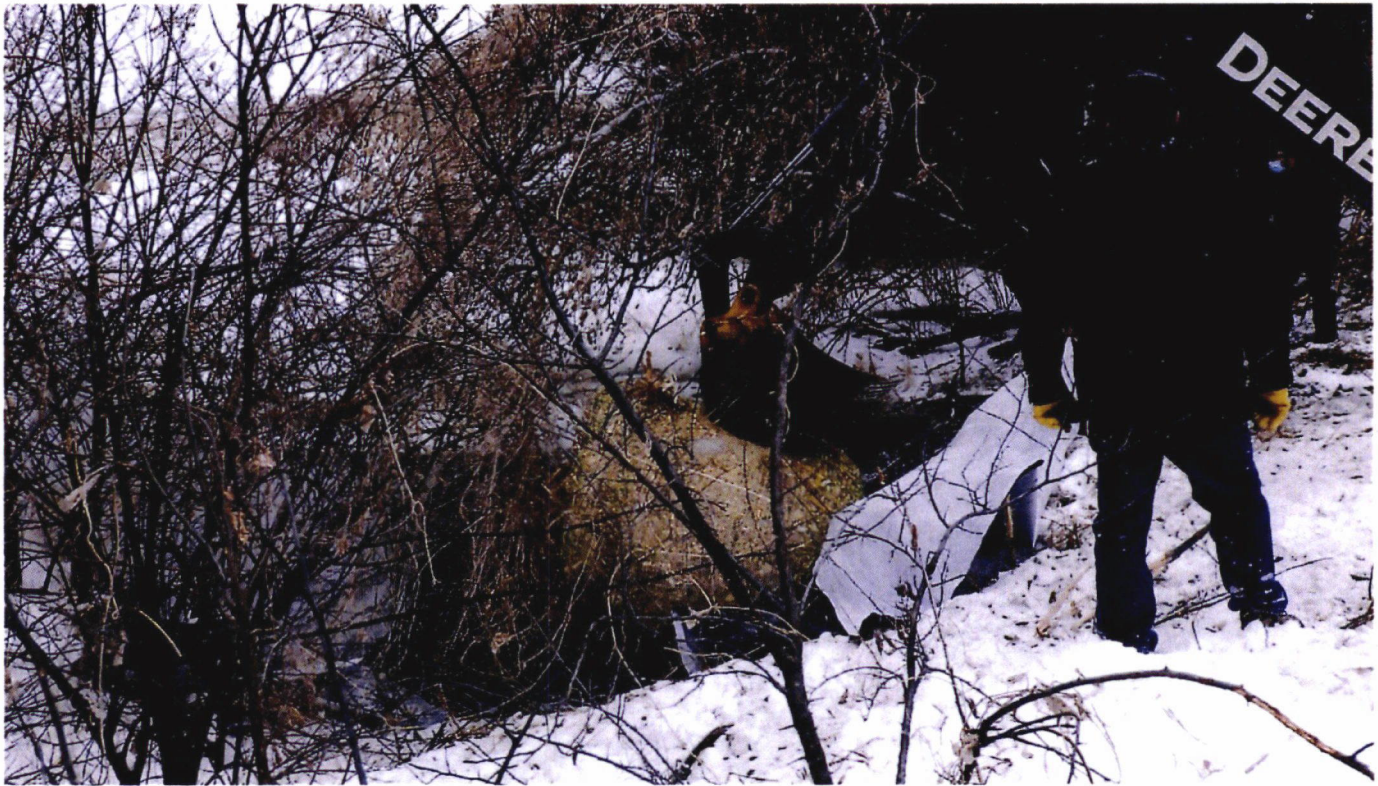
Photo 15

Description: This photo depicts UNL using a backhoe to push a bale and plastic into place.

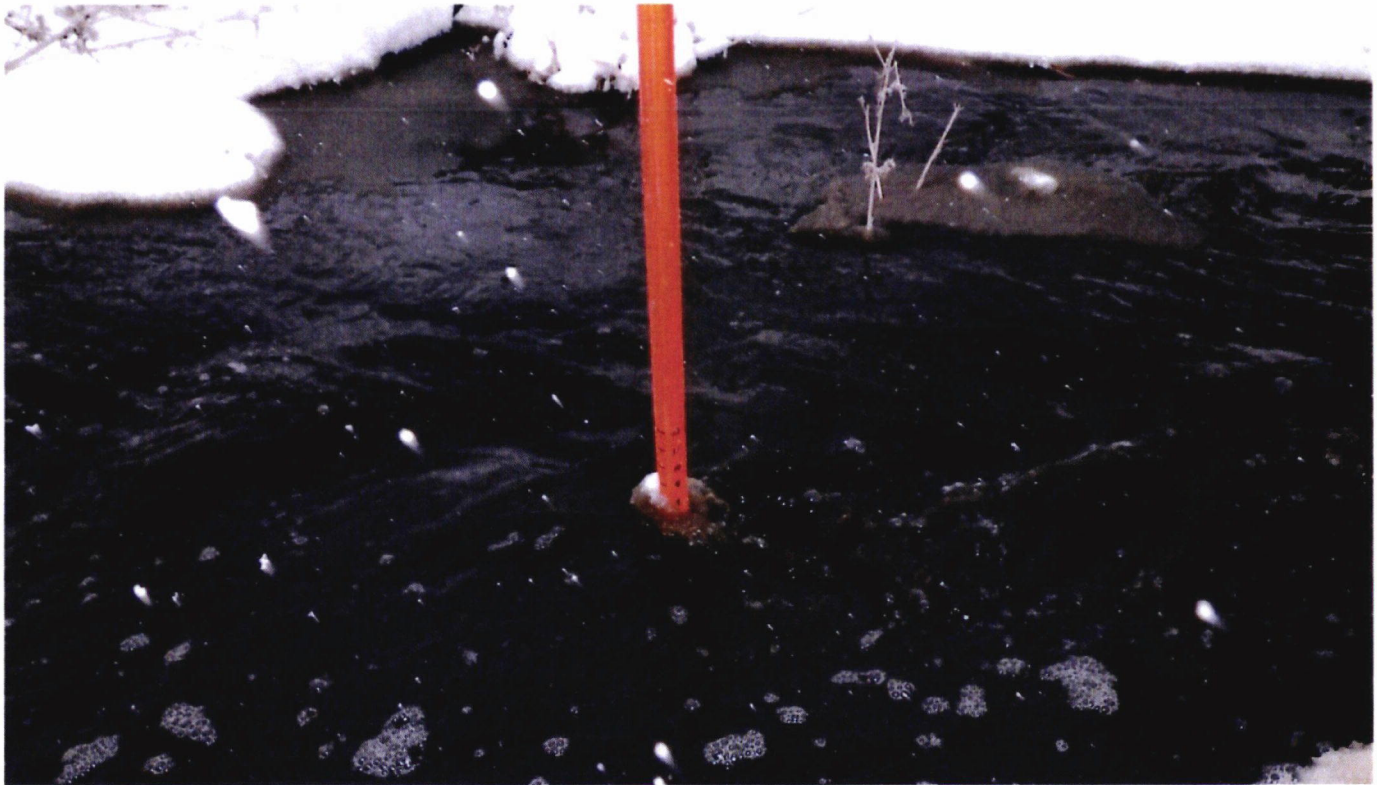
Photo 16

Description: This photo depicts UNL property adjacent county road 9. This photo is a depth finder that UNL installed to measure flow. Mr. Brummel (UNL) stated that water depth had been rising 2 inches per hour.

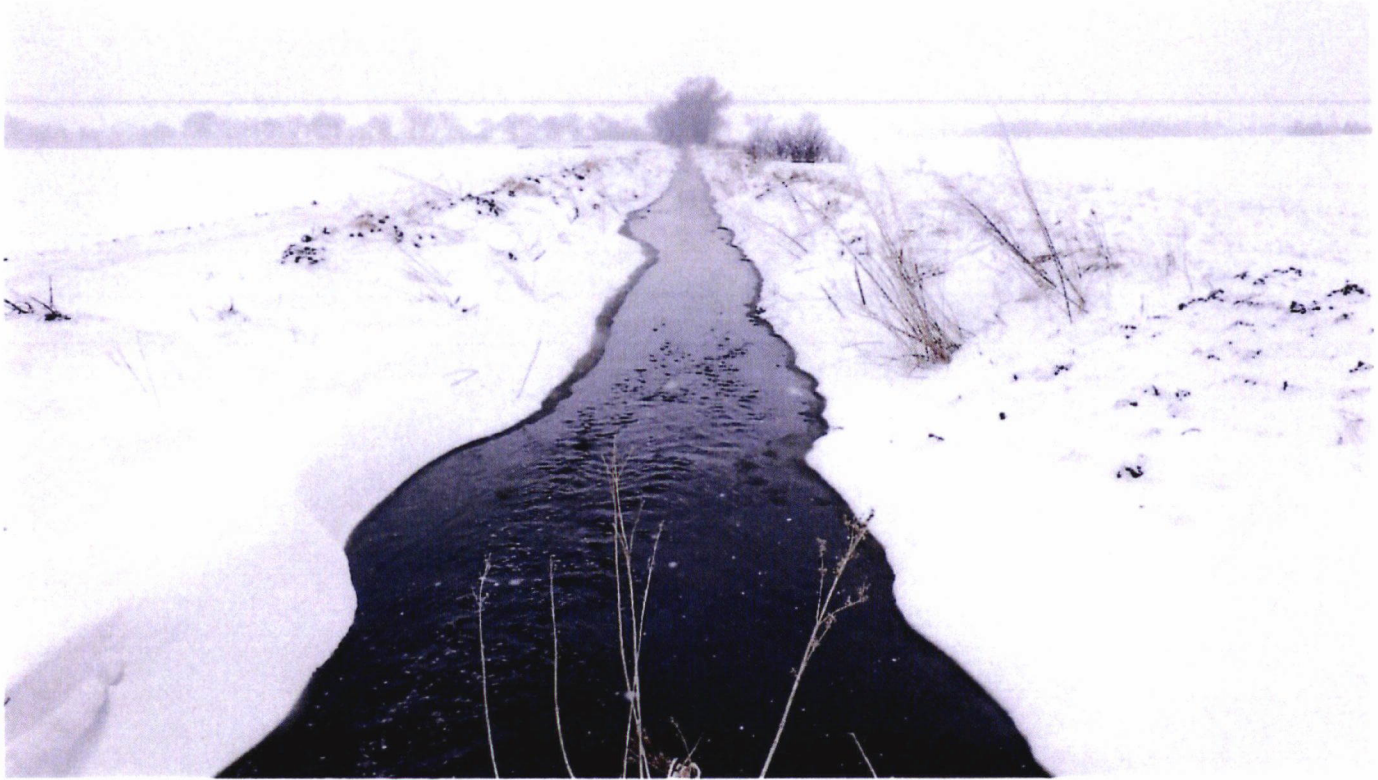
Photo 17

The flow continued through the culvert and then entered UNL property. Prior to investigating UNL property, I met with Sheldon Brummel (UNL). Mr. Brummel agreed to escort me to various locations to document flow. Mr. Brummel provide access to the first culvert site. I observed dark colored water and odor near a depth finder. Mr. Brummel stated that they have sampled the location all day and the depth has steadily increased, photo 16. I took photos from this area documenting the flow and dark colored water, photo 17.

Description: This photo is from the same area as the above photo. This photo is facing south from onto the culvert. I observed dark water and odor at this location.

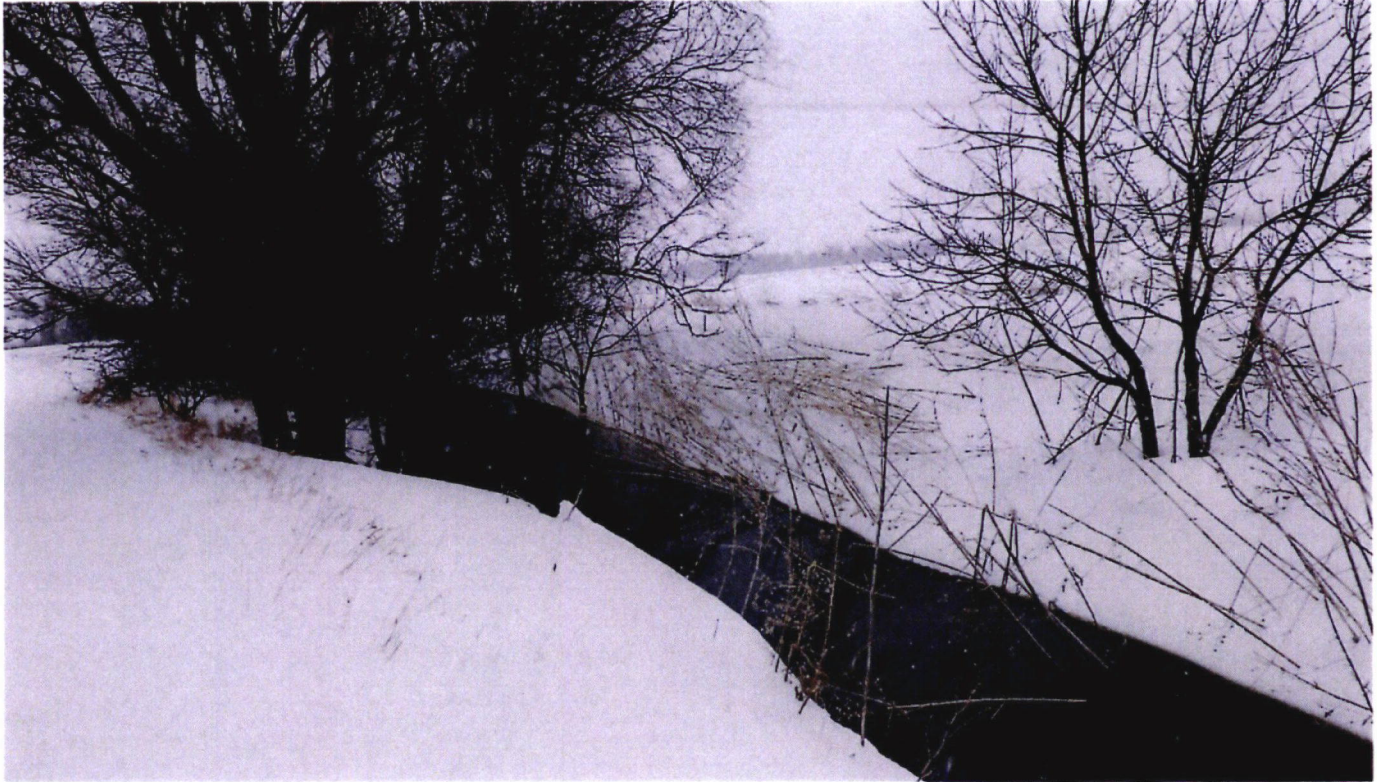
Photo 18

Mr. Brummel drove farther downstream. I again observed flow, dark colored water and noted odor, photo 18.

Description: This photo depicts an area deep into UNL property. I observed flow, dark water and odor.

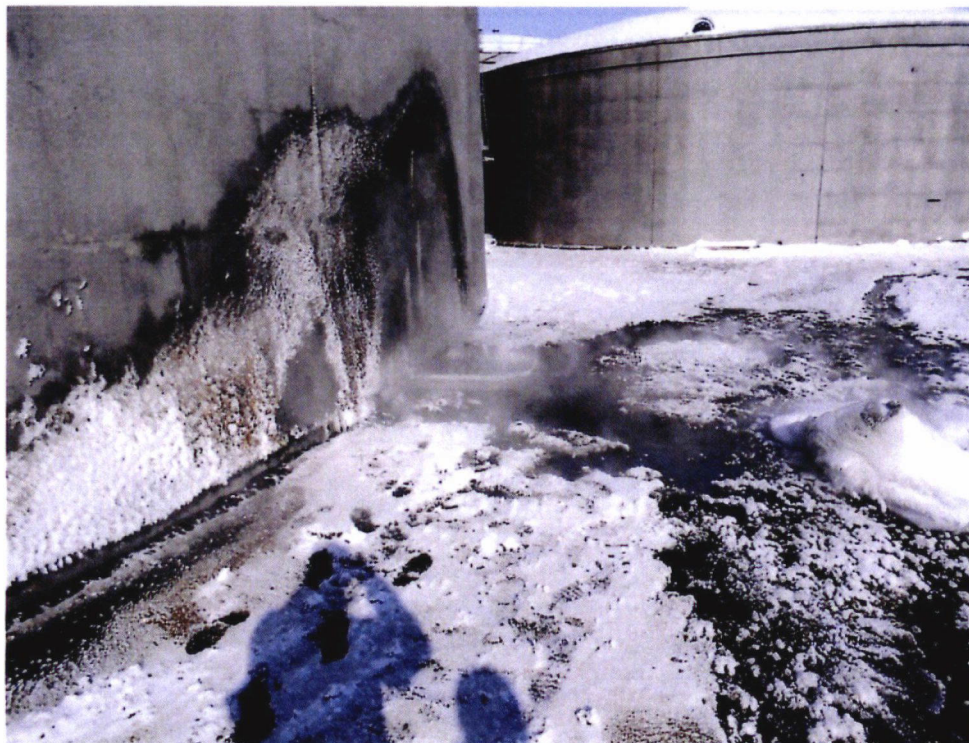
View north of piping vault where leak occurred

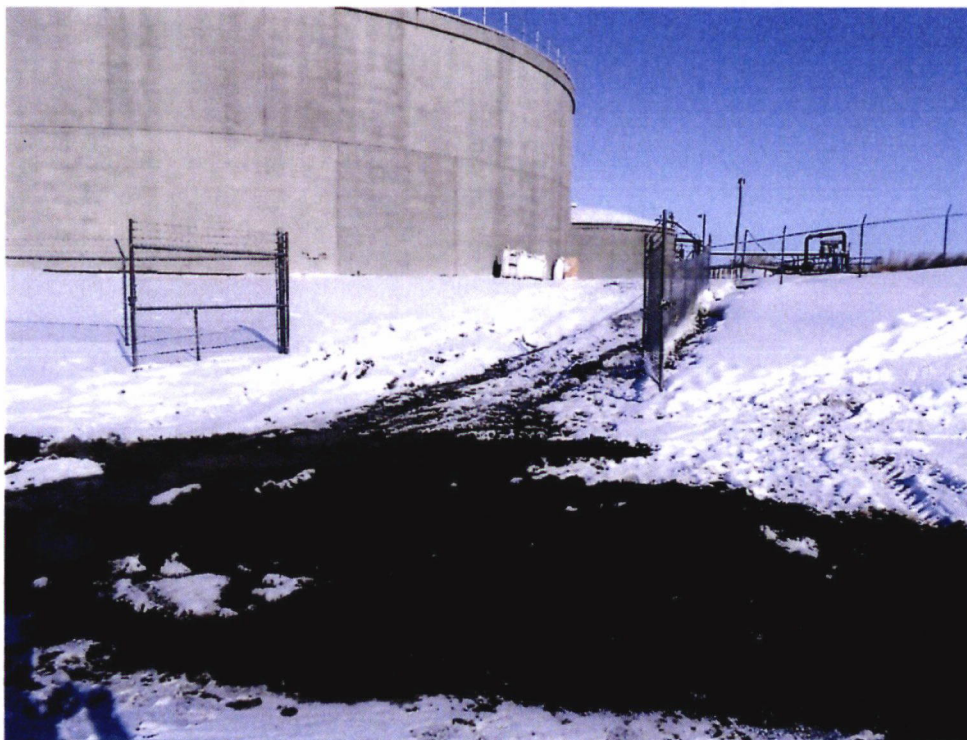
View north of digester where leak occurred

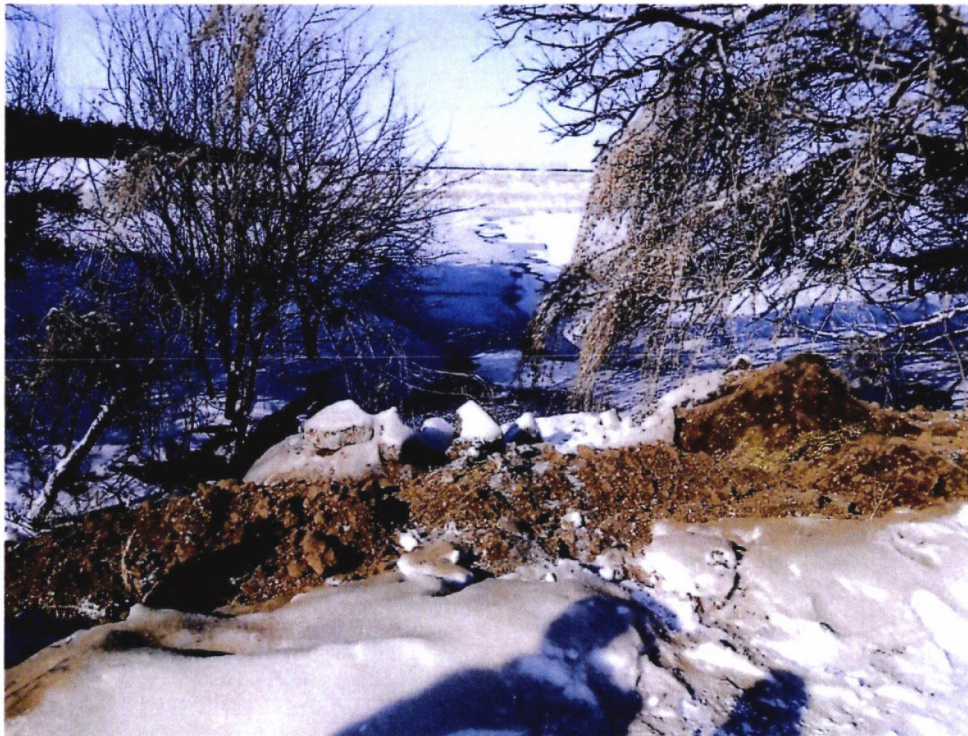
View WNW of dam upstream of culvert A

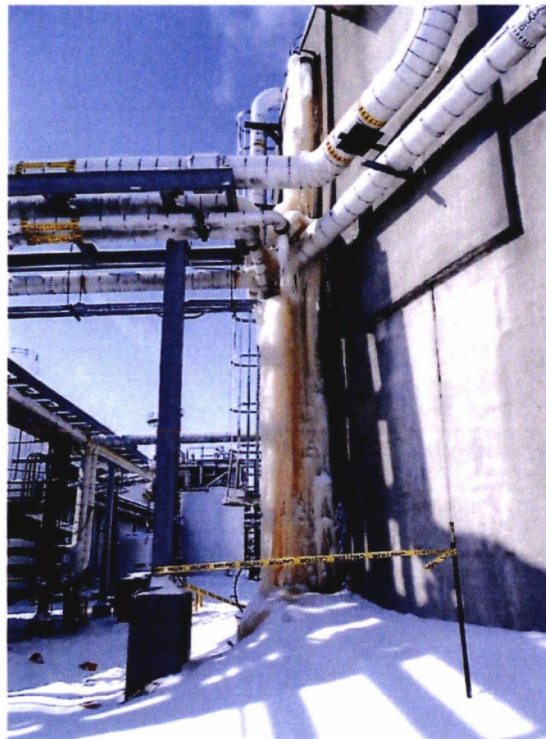
Spilling and leaking liquid from digester without leak
