BEFORE THE NEBRASKA DEPARTMENT OF ENVIRONMENT AND ENERGY

IN THE MATTER OF)	
AltEn, LLC,)	CASE NO. 3546
)	
FID # 84069)	EMERGENCY COMPLAINT
)	AND ORDER
Respondent.)

ATTACHMENT I Photographs

Release of Thin Stillage and Cattle Manure from Digester at AltEn LLC, IIS #84069, RA
#021221-NH-0845

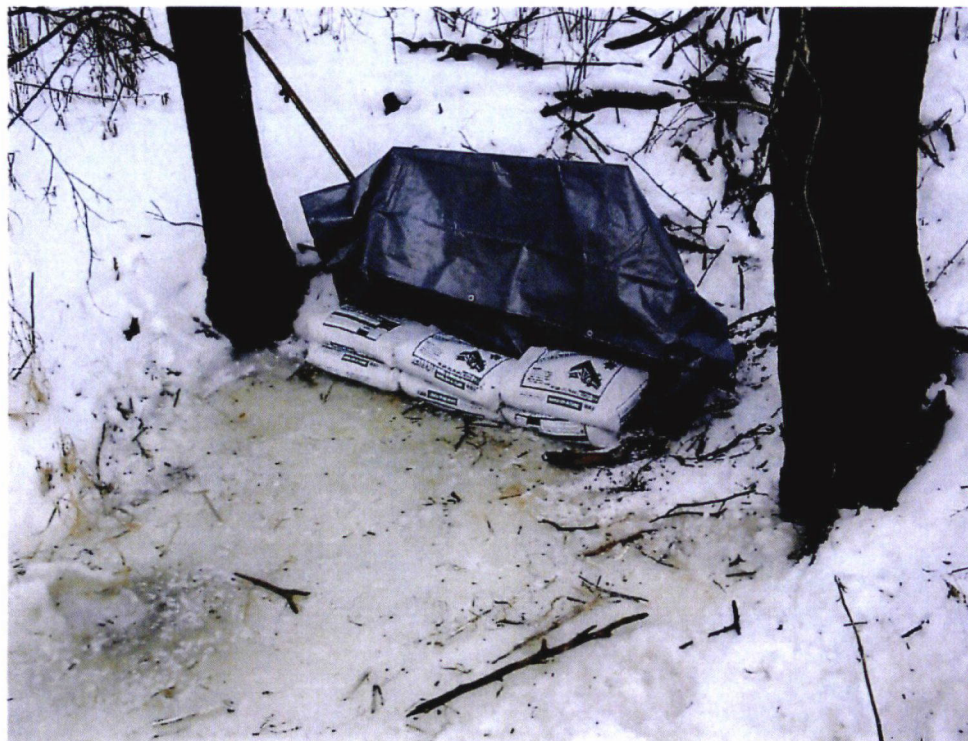
Containment structure in culvert inlet at Stop #3

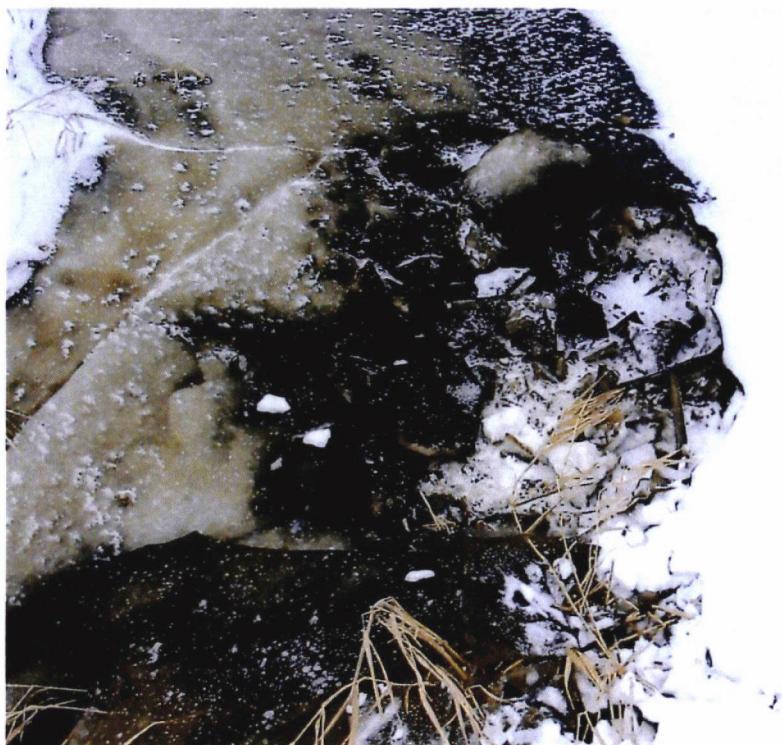
Broken crust of ice at culvert inlet at Stop #4

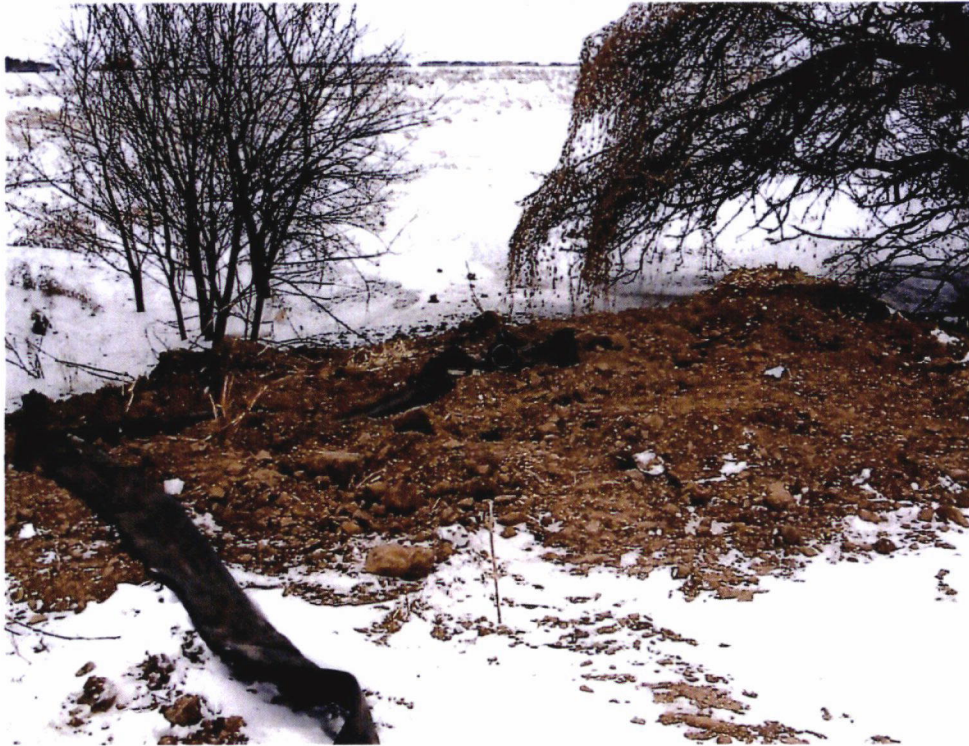
View west of dam upstream of Stop #5

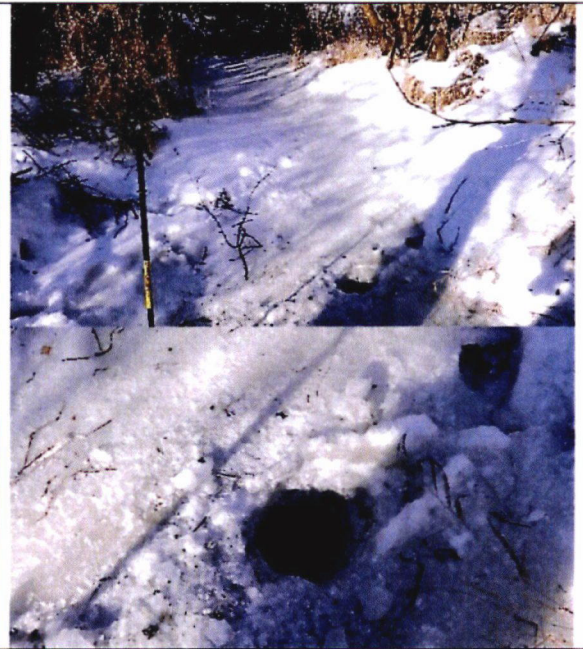
STOP 4 – County Road 8, North of Road H

The AltEn LLC thin stillage discharge water remains as a frozen layer on top of the original ice layer that existed prior to the thin stillage release. The frozen waste water ice is much darker in appearance than the snow and original ice in the channel. The darker, frozen top layer was easily broken by walking on it. I did chop a hole through the channel's original ice layer (~12 inches thick) and found water underneath at this location. I do not believe the water to be the thin stillage waste, as there was no pressure from below that filled the hole I had opened. However, I did not have a meter with me to confirm to be true.

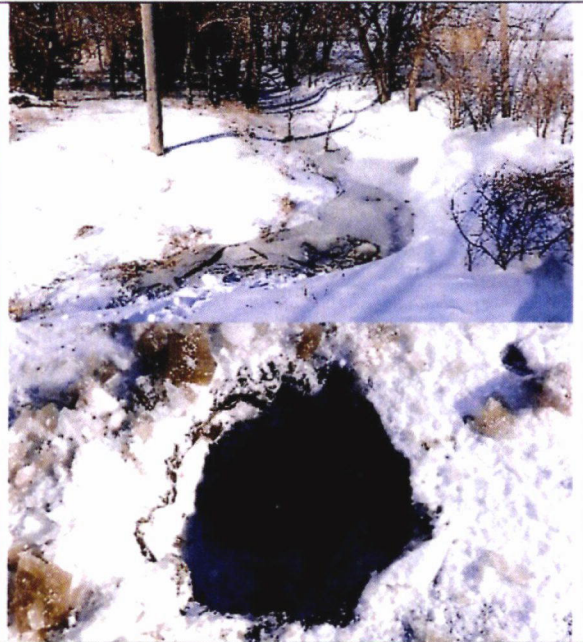
STOP 5 – UN-L Eastern Extension – North of County Roads 9 & J

The AltEn LLC thin stillage discharge water remains as a large pooled area behind the make-shift dam constructed on the upstream (west) side at this location. Ken Peterson (AltEn Plant Manager) showed up while I was at this location. He told me they had placed additional earthen material here to stop the seepage through the culverts. He also said they planned to start pumping the liquid from this location back into a lagoon yet today. A hose was stretched out in this area, but no pump was in place when I was there.

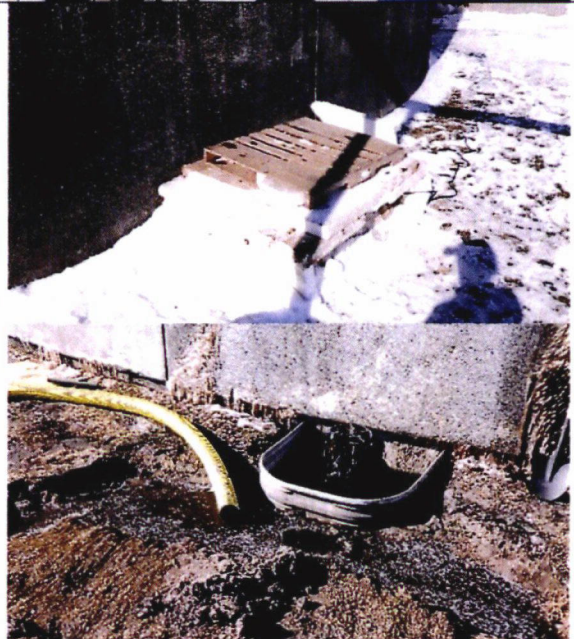
STOP 6 – ALTEN LLC FACILITY DIGESTERS

Ken Peterson (AltEn Plant Manager) led me to the digesters and gave me a quick tour. I did not observe any discharges from either the north or south stillage tank. The top photo is the covered pipe/valve housing on the north tank and the bottom photo is of the one that failed on the south tank.
