BEFORE THE NEBRASKA DEPARTMENT OF ENVIRONMENT AND ENERGY

IN THE MATTER OF)	
AltEn, LLC,)	CASE NO. 3546
)	
FID # 84069)	EMERGENCY COMPLAINT
)	AND ORDER
Respondent.)

ATTACHMENT I Photographs

Release of Thin Stillage and Cattle Manure from Digester at AltEn LLC, IIS #84069, RA
#021221-NH-0845

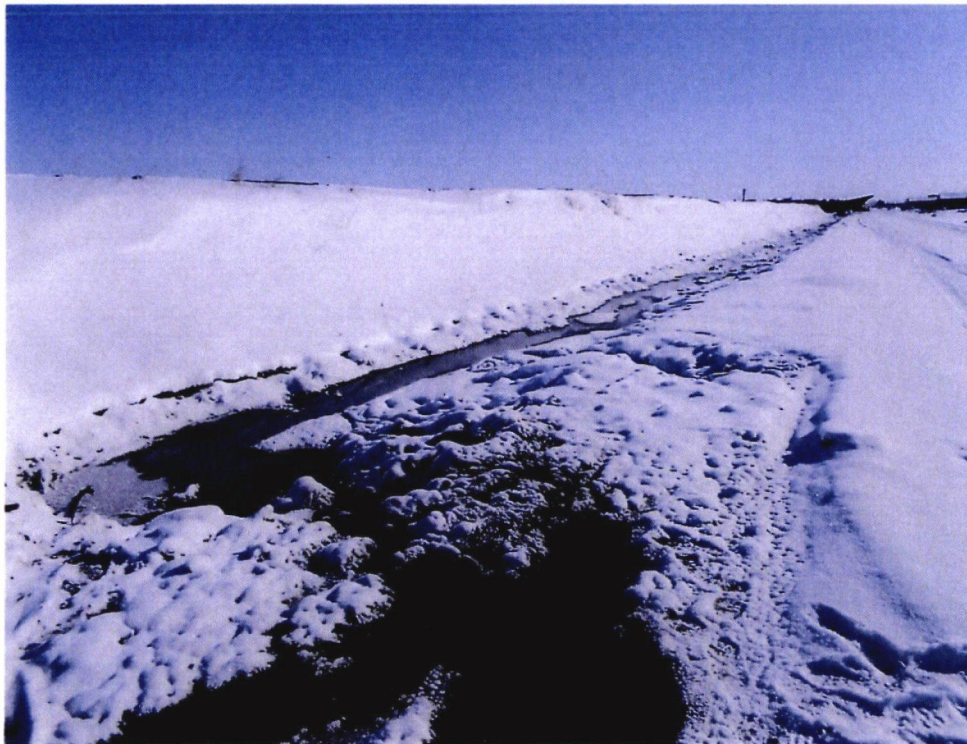
View east from near digester toward road ditch

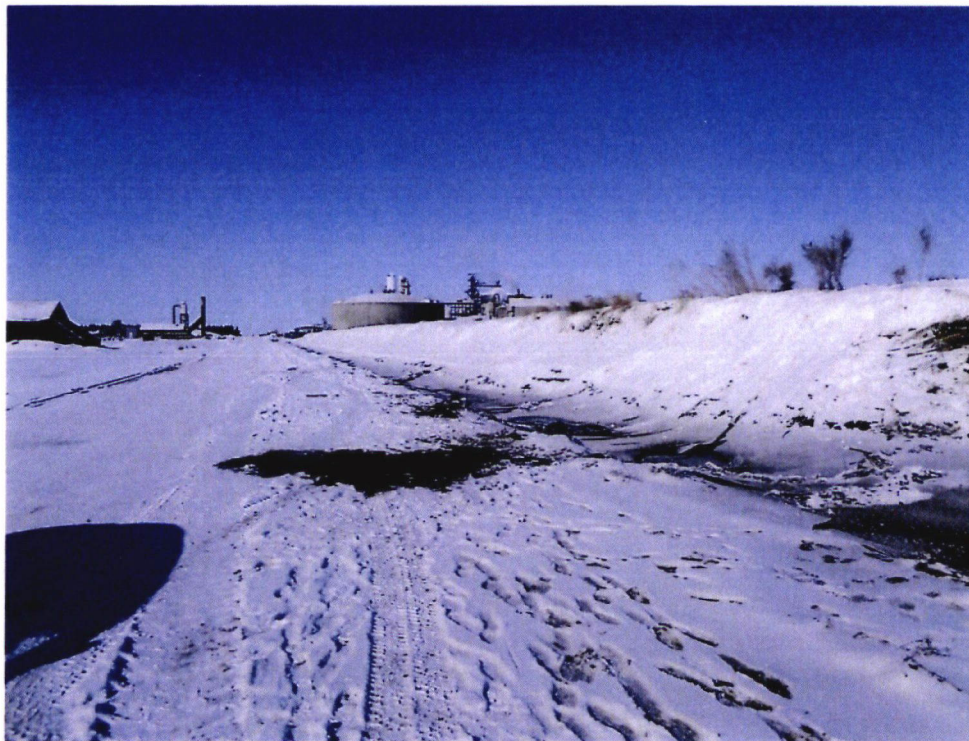
View west of road ditch with digester in background

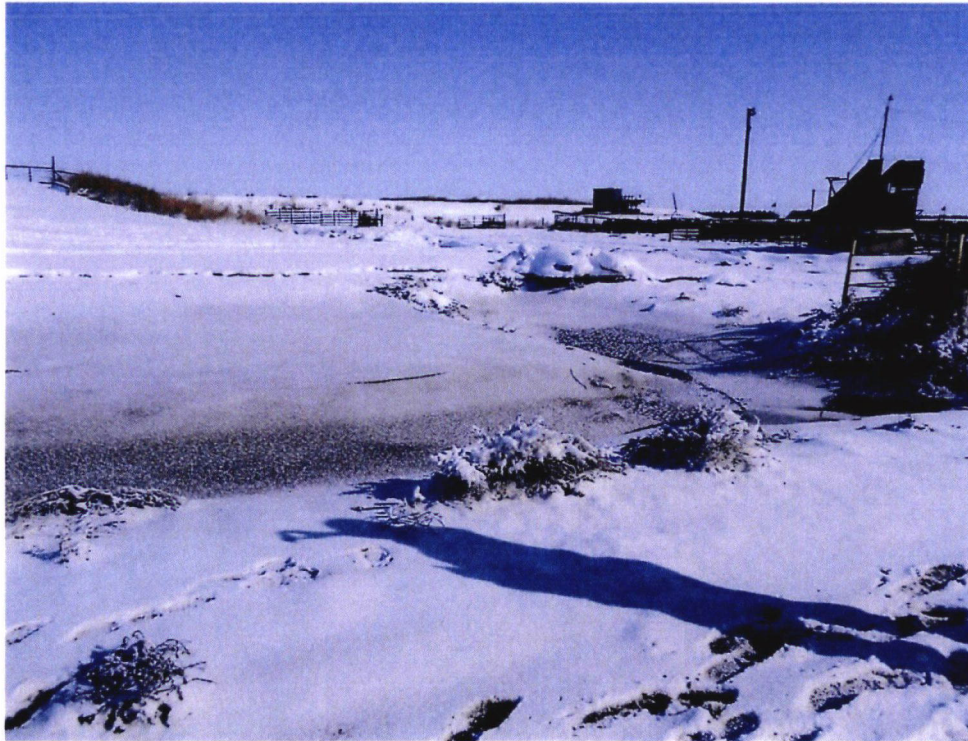
View NE of ditch near Mead Cattle Company

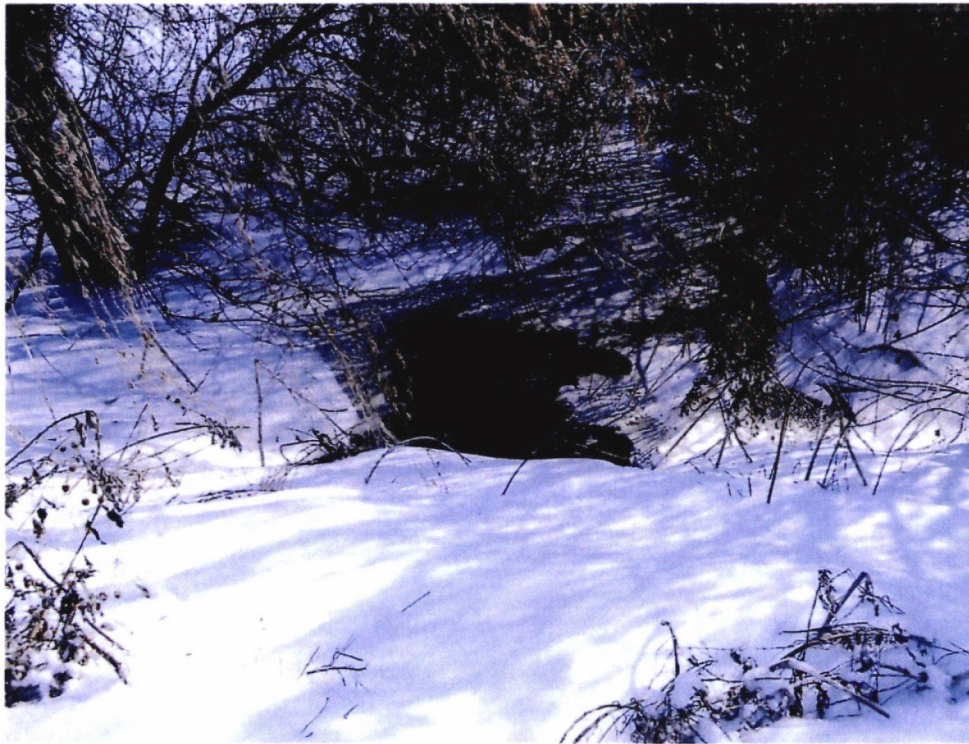
View east of ditch downstream from culvert A

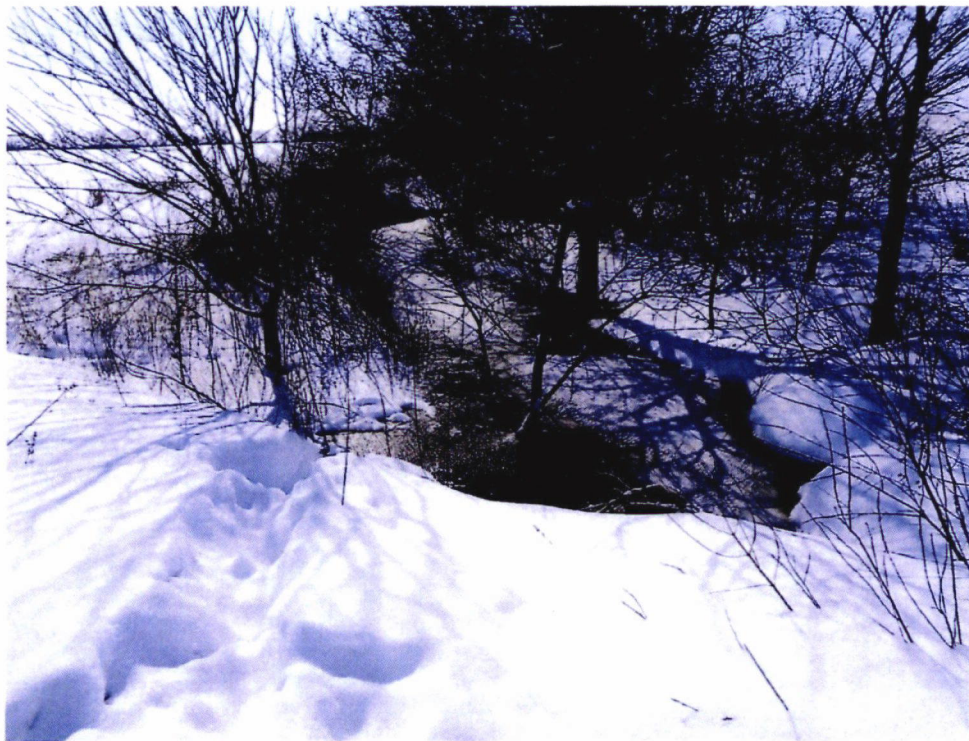
Mark and I proceeded to the next downstream location, depicted as culvert B on the attached Google Earth image, where the ditch intersected with a roadway. We observed liquid flowing through the culvert (see attached photos). Based upon the cold temperatures that we presume would have frozen any pre-existing water and the odor associated with the flowing liquid we observed, that the flowing liquid was likely what had spilled from the digester.

View north of ditch upstream from culvert B

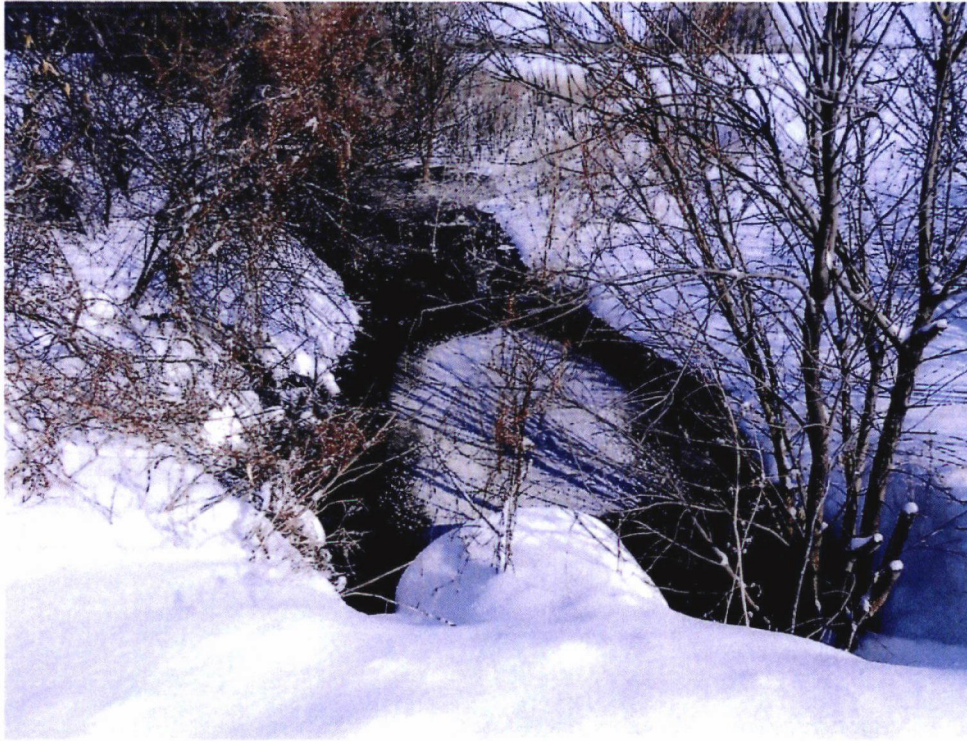
View south of ditch downstream of culvert B

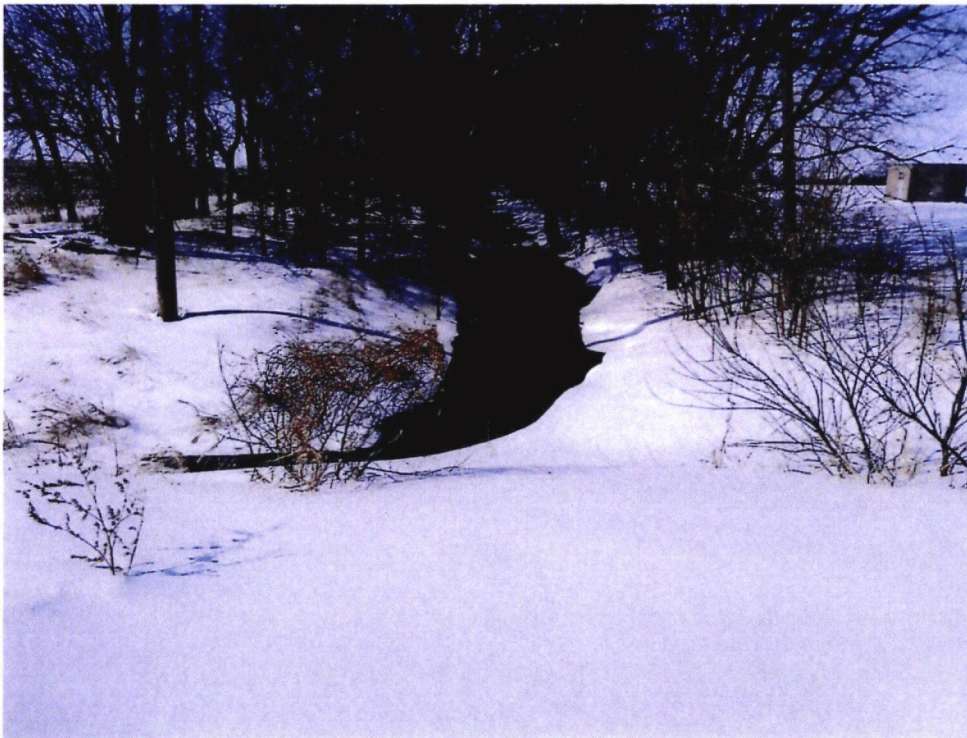
Mark and I proceeded to the location depicted as culvert C on the attached Google Earth image. We observed liquid flowing through the culvert (see attached photos). We proceeded to the location depicted as culvert D on the attached Google Earth image. We observed an inch or two of liquid on top of existing ice and within the snow cover (see attached photos). There was no obvious flow of this liquid. The liquid did exhibit an odor similar to the liquid spilled from the digester.

View north of ditch upstream from culvert C

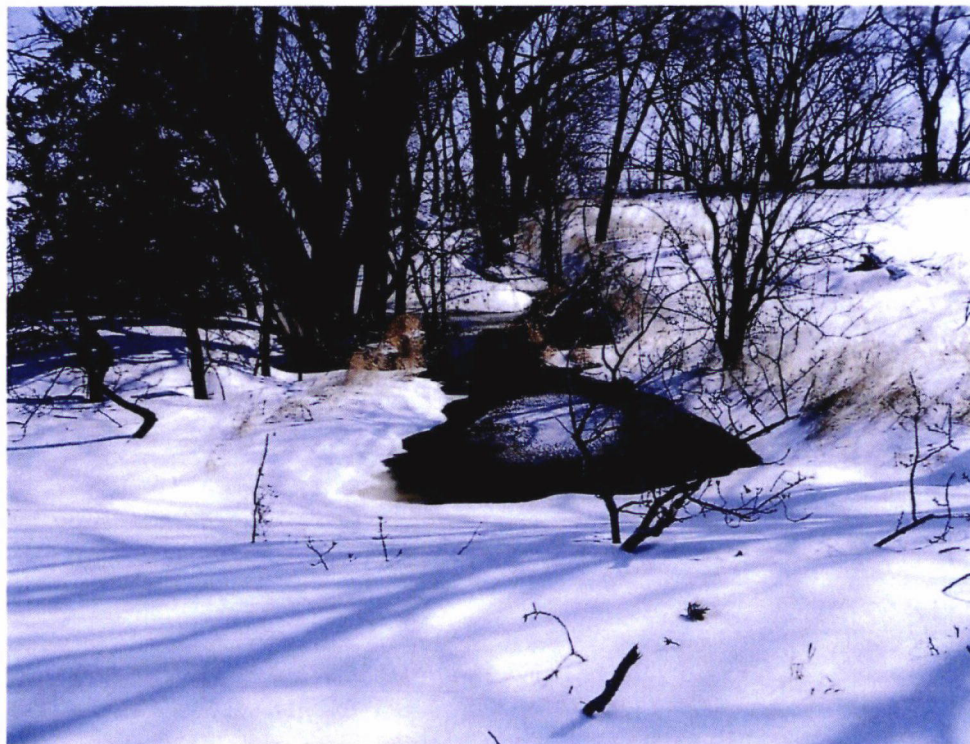
View south of ditch downstream from culvert C

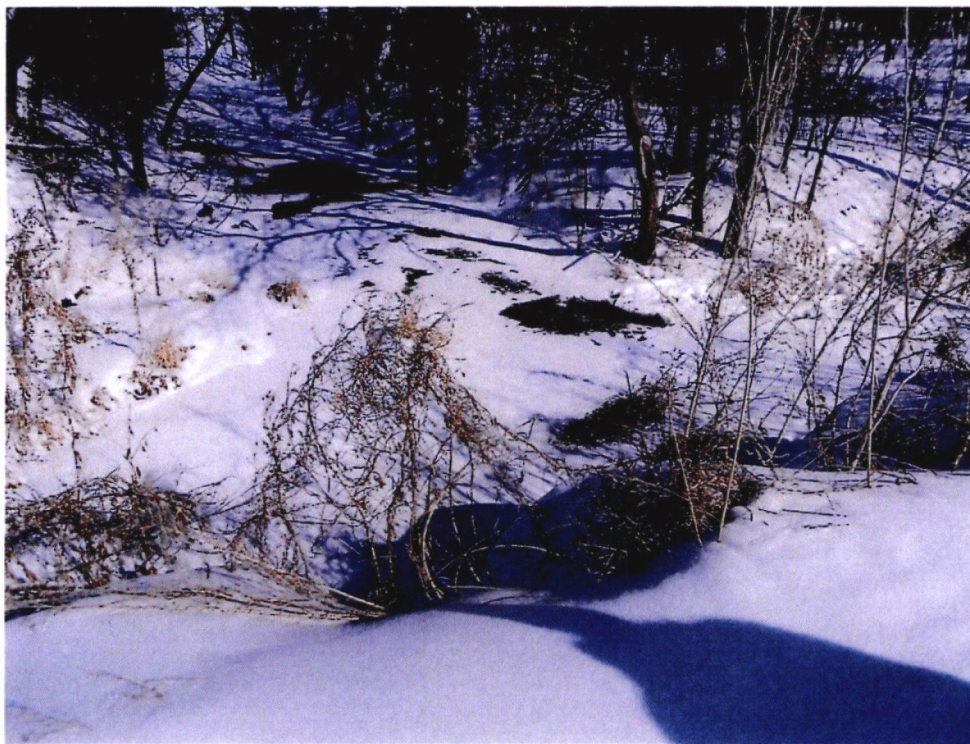
View north of ditch upstream from culvert D

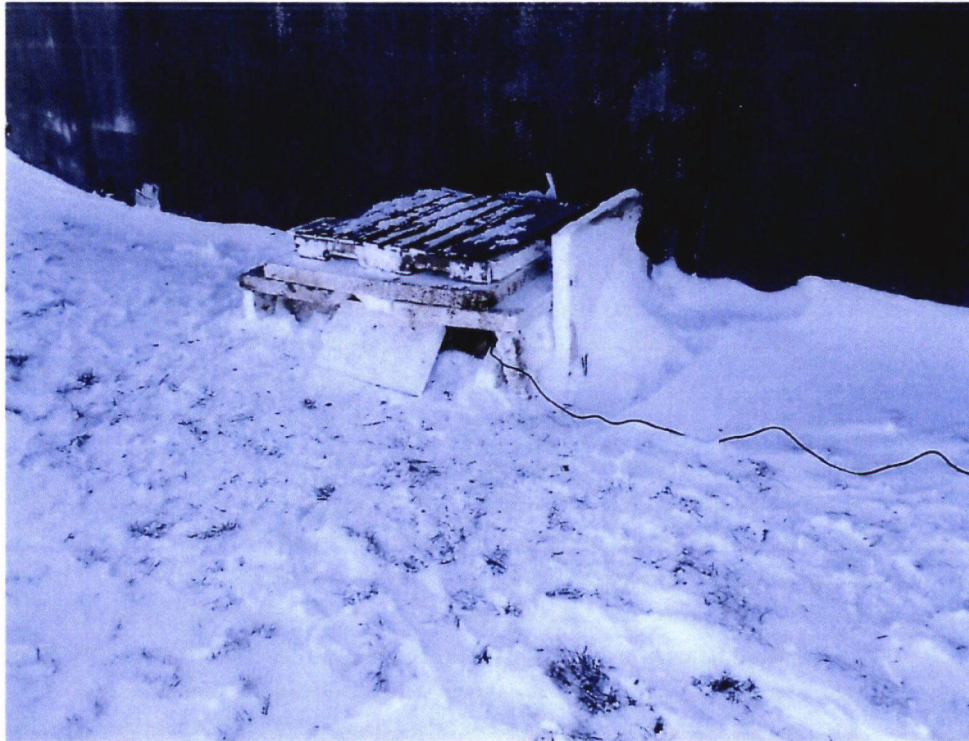
We returned to the AltEn facility to examine the digester that had not suffered a release. We observed a pile of Styrofoam insulation panels we presumed were covering the piping vault (see attached photo). We observed electrical wiring leading under the pile of insulation and presumed that to be for the heat lamp mentioned by Mr. Egr. We observed on the south side of the digester that had not suffered a leak a column of ice surrounded by caution tape (see attached photo). We could see a fitting above the column of ice actively releasing a liquid (which appeared to be freezing and creating the column of ice). We presumed this liquid was thin stillage and manure being released from the full or nearly full digester.

Insulation over piping vault on digester without leak

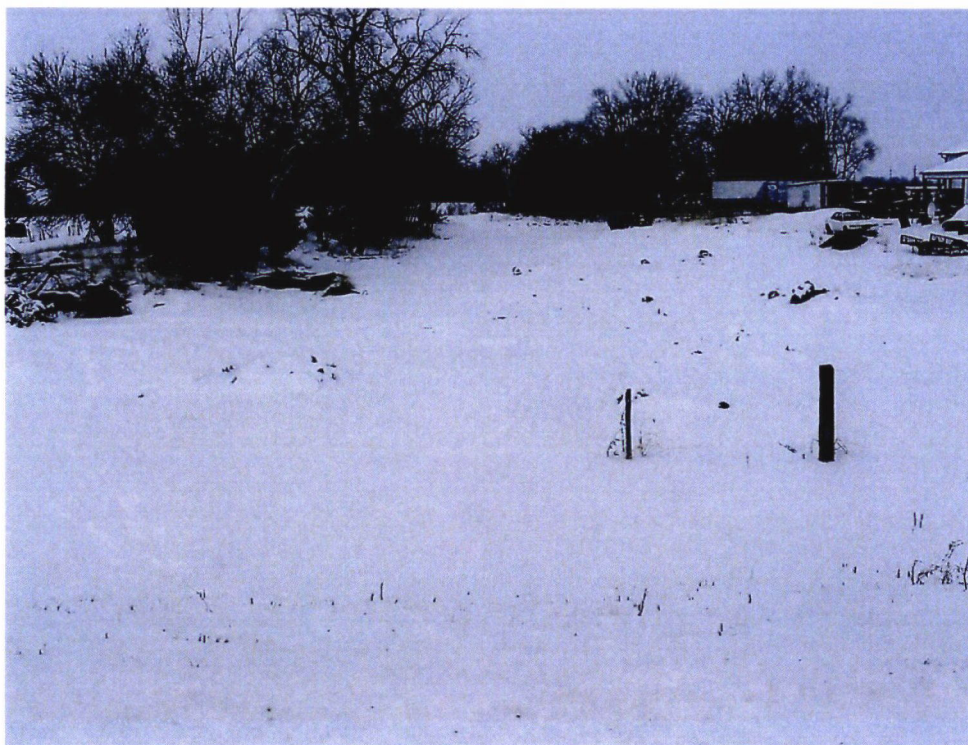
View north of ditch upstream from Stop #1

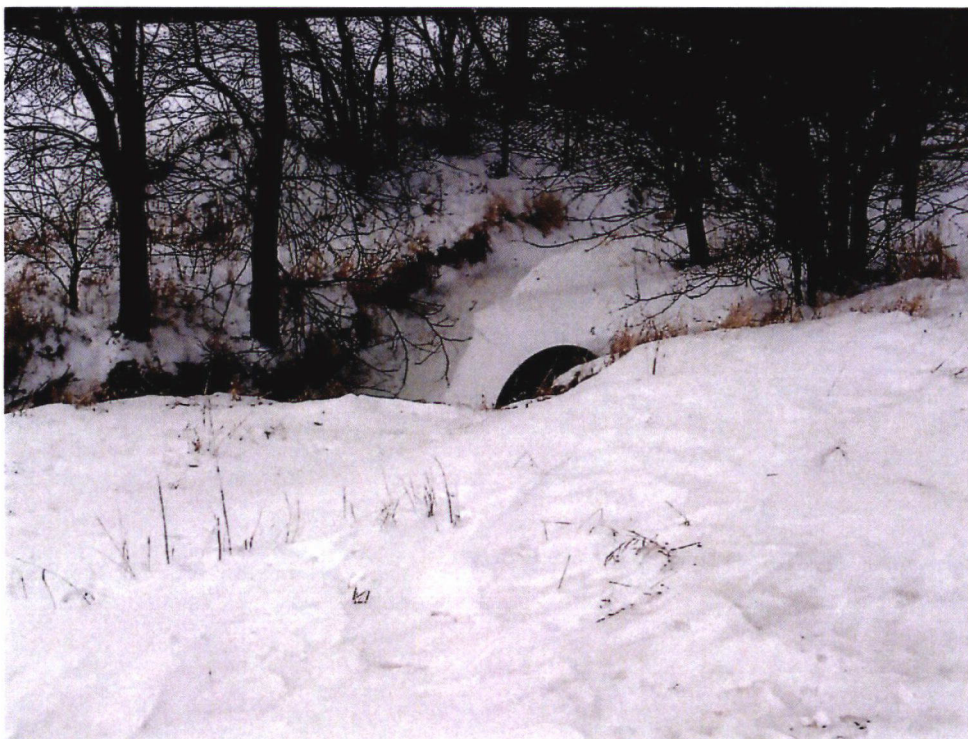
View west of ditch upstream from Stop #2

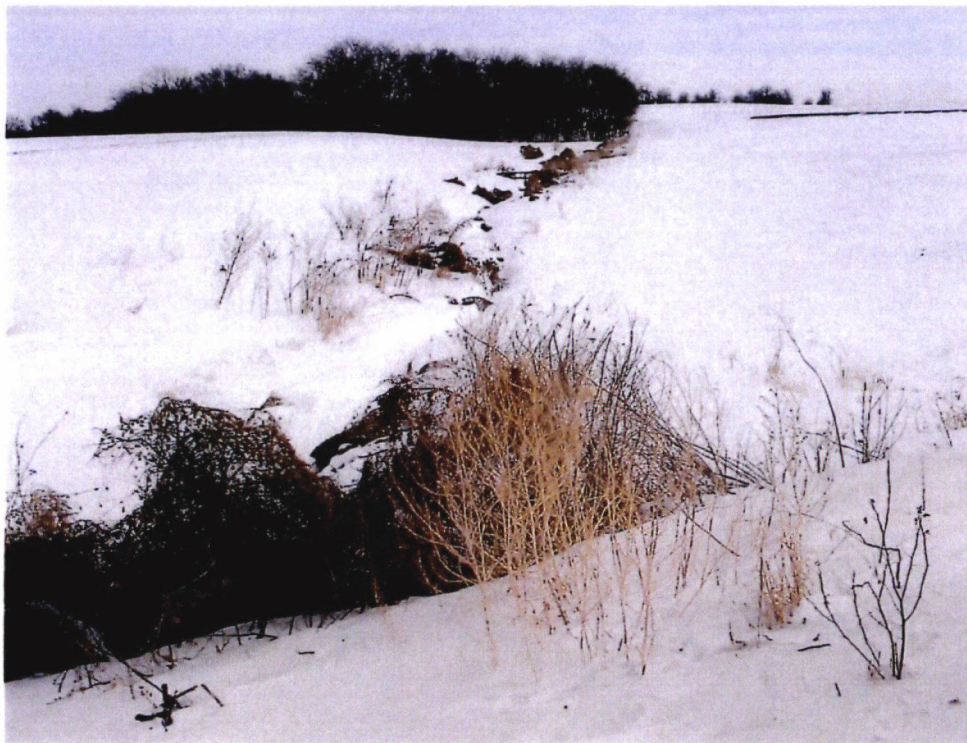
View east of ditch downstream from Stop #2

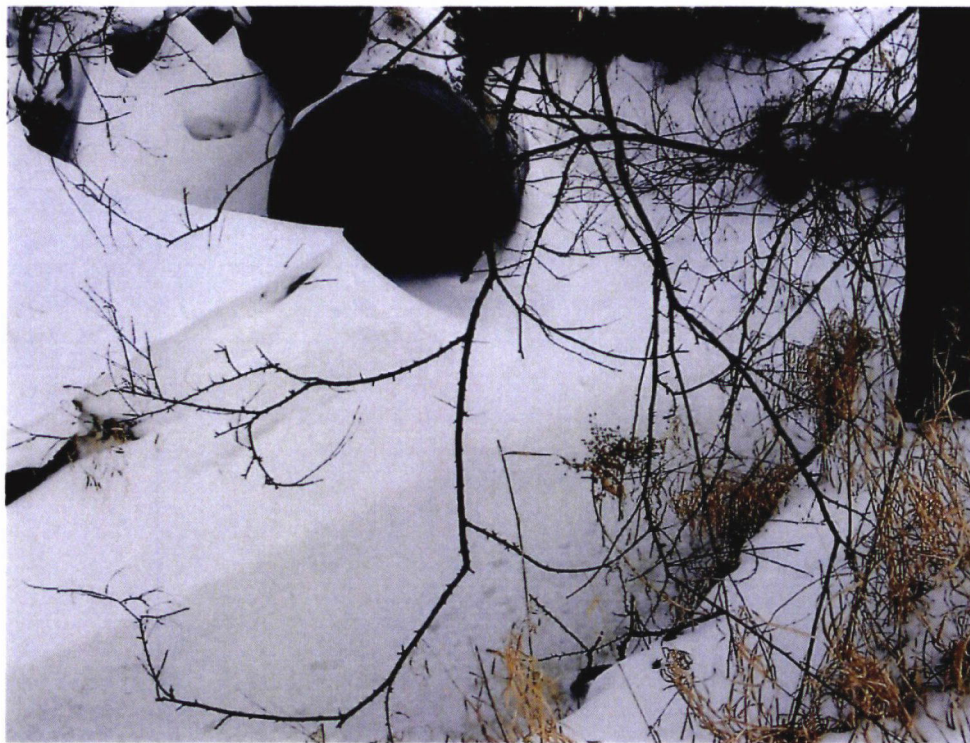
View east of upstream culvert inlet at Stop #2

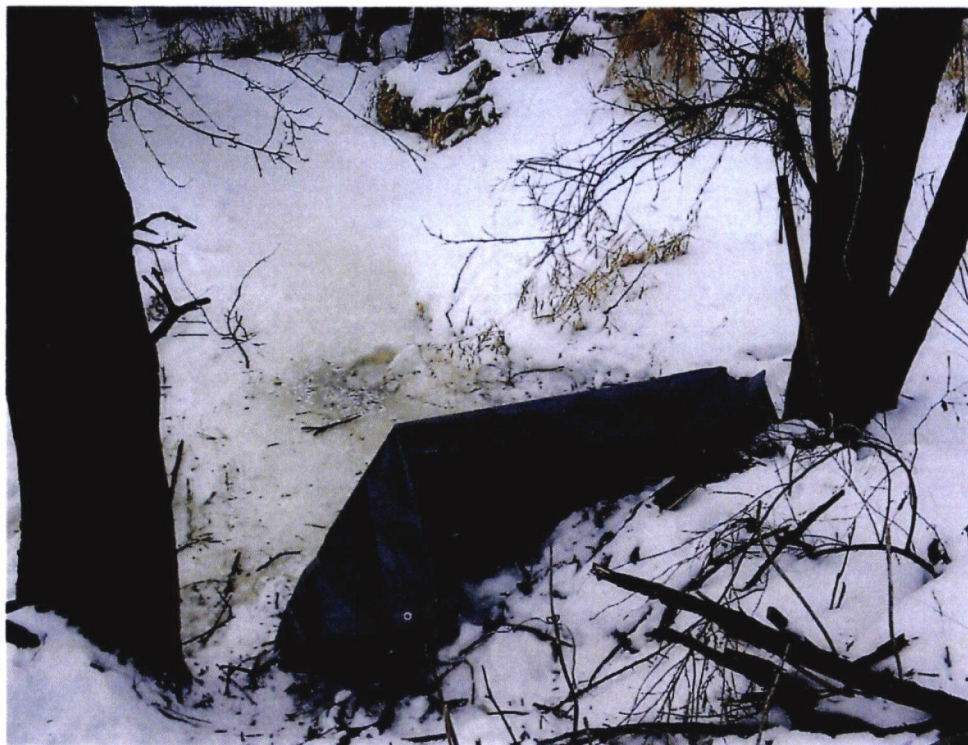
I proceeded to Stop #3. Stop #3 is located on road 7 about 1/2 mile north of road F. The surface of the liquid in the ditch at Stop #3 was frozen. I did not attempt to break through the ice to determine if there was unfrozen liquid below the ice. The ice had slight yellow/tan coloration. I observed plywood (or similar) wrapped with a tarp covering the inlet of the culvert. There were several sandbags placed at the base of the plywood/tarp to hold it in place (see attached photos). I dug through the snow at the downstream outlet of the culvert and found only ice. I did not attempt to break through the ice at the culvert outlet to look for unfrozen liquid.

View west of ditch upstream from Stop #3

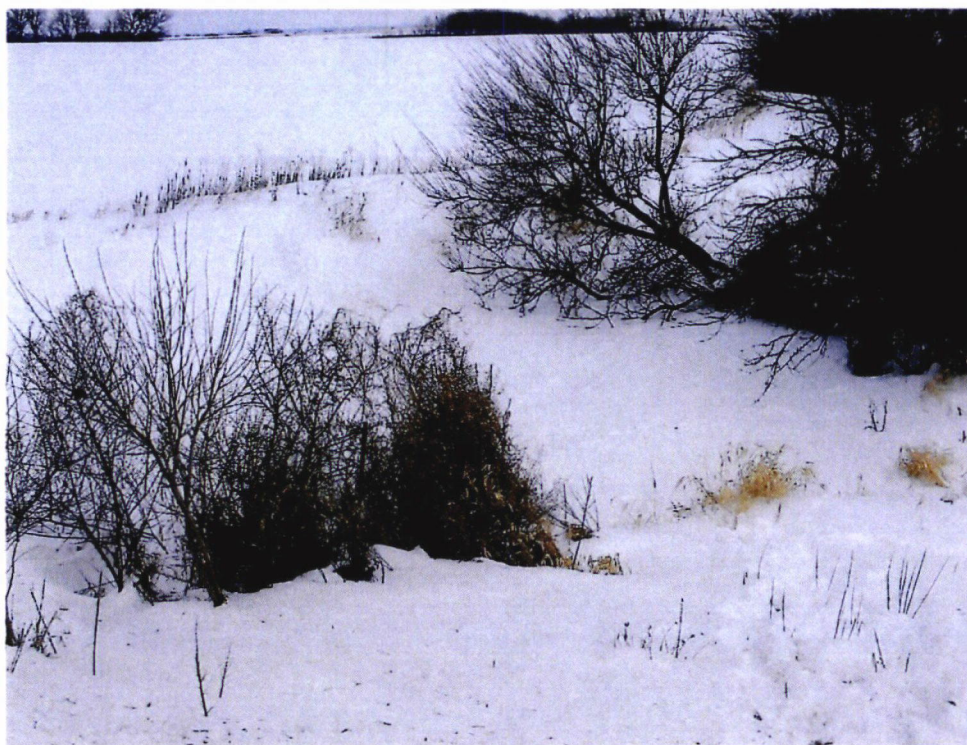
View east of ditch downstream from Stop #3

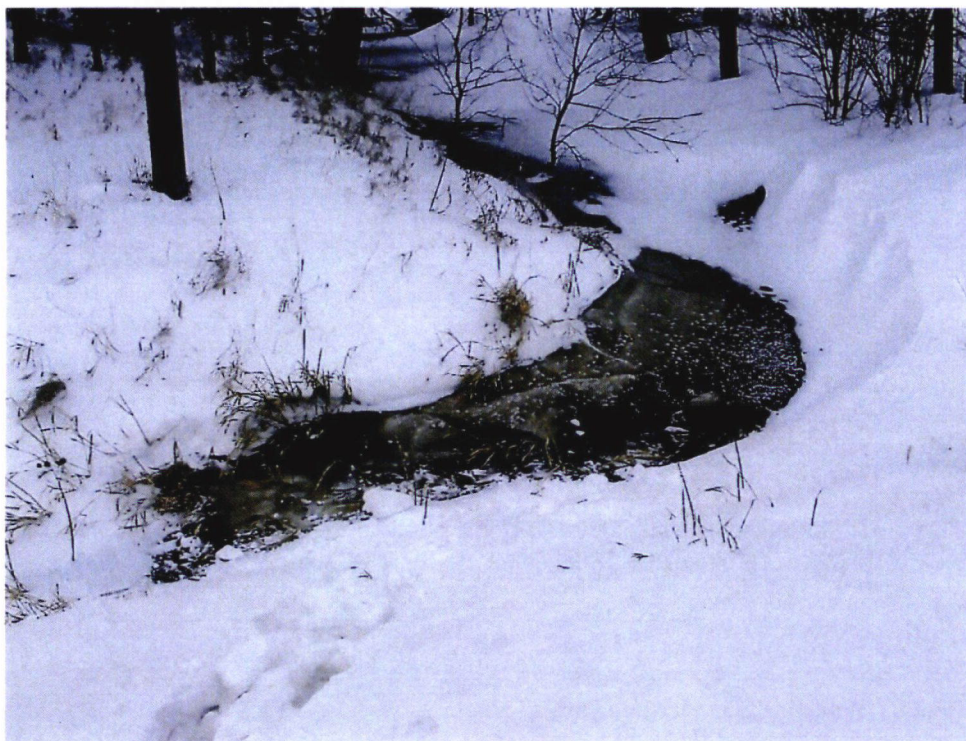
I proceeded to Stop #4. Stop #4 is located on road 8 about 1/2 mile north of road H. I observed brown-colored ice both upstream and downstream from Stop #4. Upstream from Stop #4, the ice was broken in many pieces as if it froze and the liquid below drained away (see attached photos).

View west of ditch upstream from Stop #4

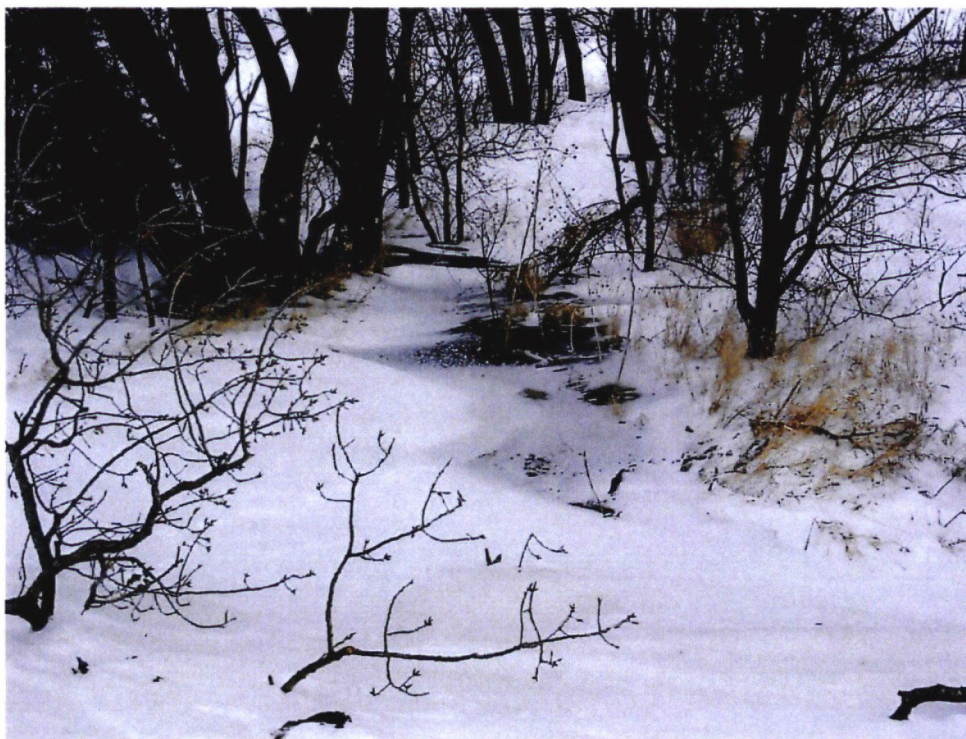
View east of ditch downstream from Stop #4

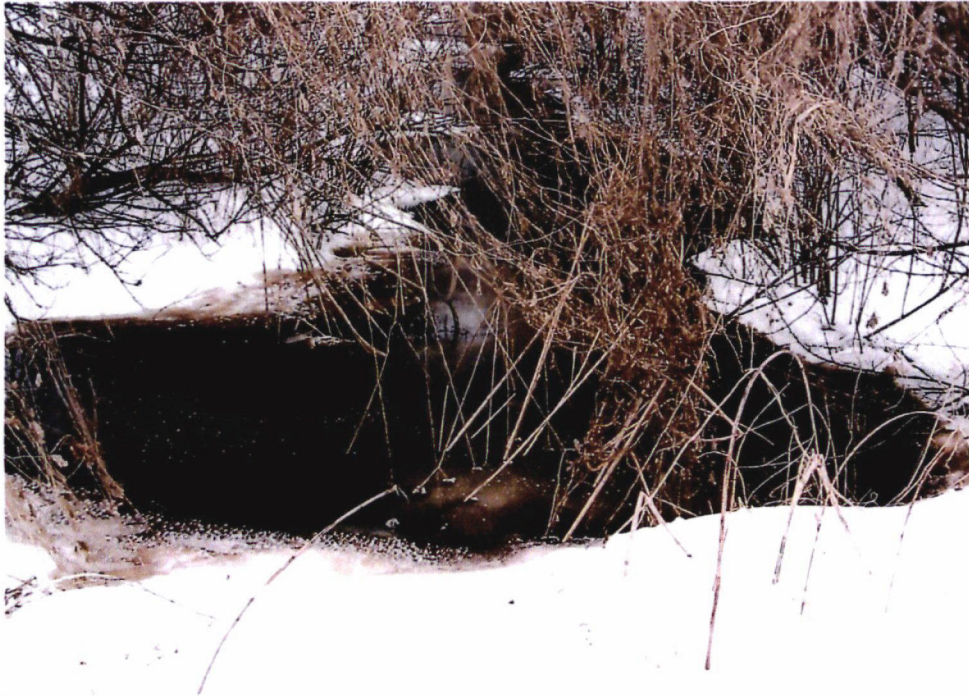
View east of ditch downstream from Stop #5

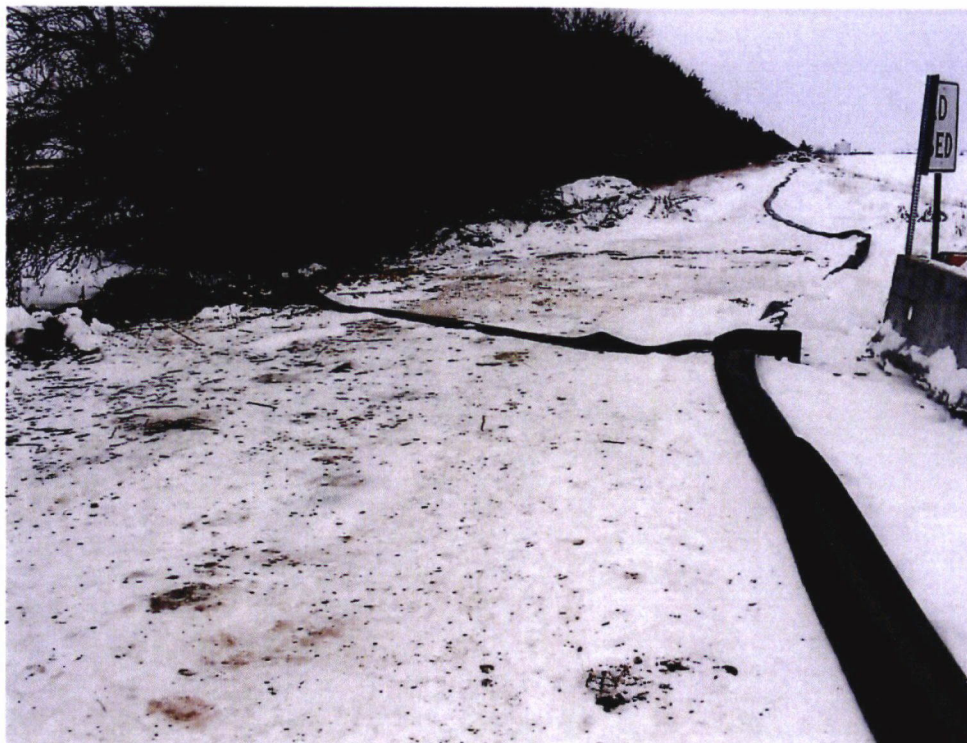
rap I had observed at this location on February 13th. It is unknown if the bales and concrete were removed, or simply covered with earth. The volume of earth present was significantly greater than the volume of earth I had observed on the 13th. I observed brown ice both upstream and downstream of Stop #5. I made no attempt to break through the ice to determine if flowing liquid was present below the ice. I observed flexible piping laid out near Stop #5 and extending some distance to the north (see attached photos).

View north of piping laid out at Stop #5

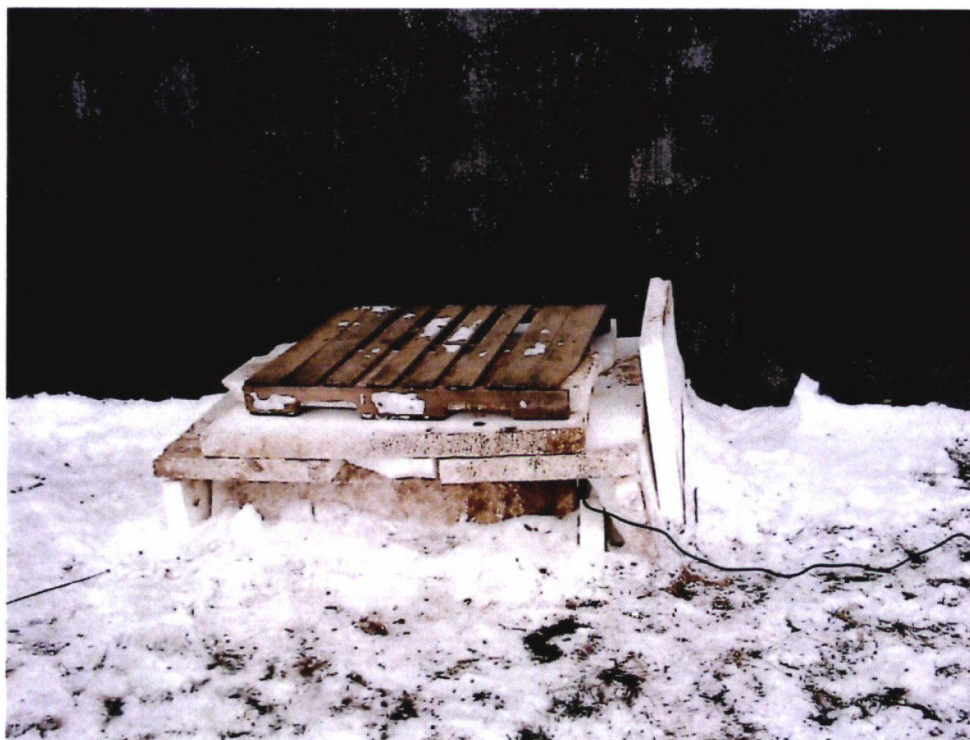
Insulation over piping well on digester w/out leak

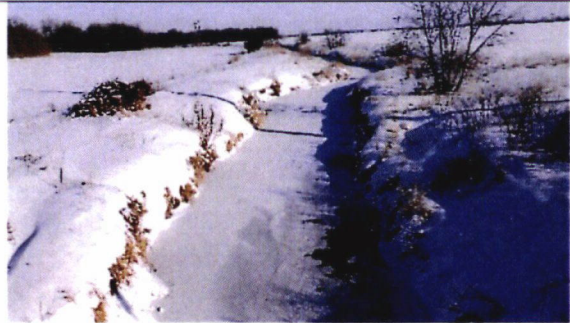
Clear Creek at this location was 99% ice/snow covered. There was a couple of open water areas, but site is currently not impacted from the AltEn LLC thin stillage discharge. Photo is looking north (upstream).

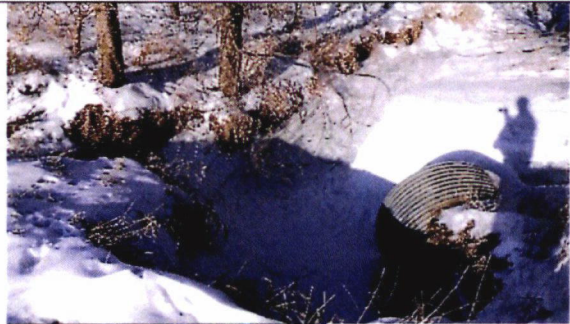
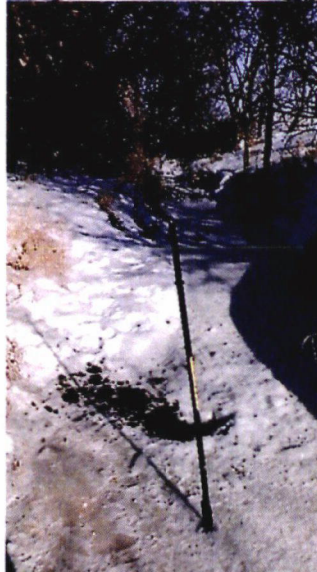
**STOP 2 – North of the Intersection of
COUNTY ROADS 6 & F**

I found no evidence of the AltEn LLC thin stillage discharge reaching this location. I chopped a hole in the ice (~10 inches thick) to the channel's substrate. It was completely frozen, with no water below the ice. Photos were taken looking west/northwest (upstream).

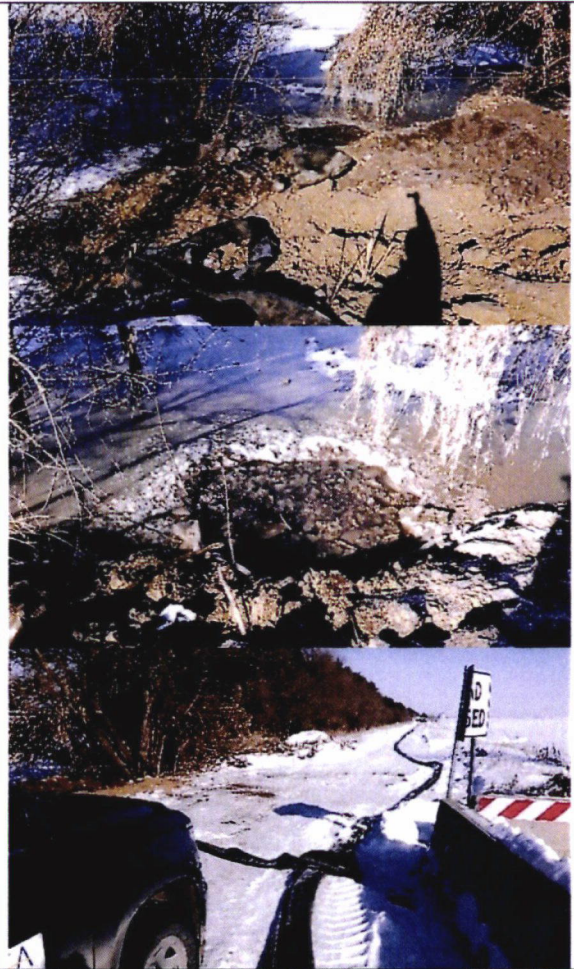
The AltEn LLC thin stillage discharge water remains as a large pooled area behind the make-shift dam constructed on the upstream (west) side at this location. Ken Peterson (AltEn Plant Manager) showed up while I was at this location. He told me they had placed additional earthen material here to stop the seepage through the culverts. He also said they planned to start pumping the liquid from this location back into a lagoon yet today. A hose was stretched out in this area, but no pump was in place when I was there.

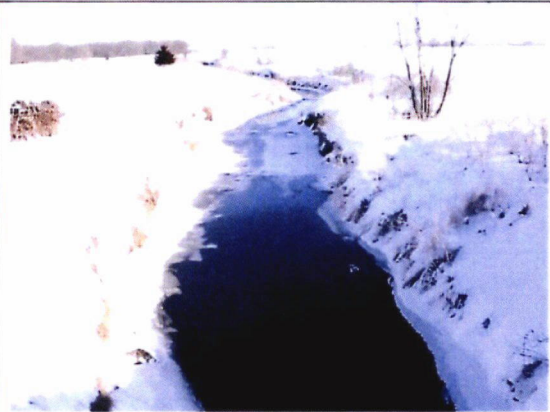
Nothing to see here other than water and ice;
no apparent impacts.

Photo looking north from Highway 66 bridge.

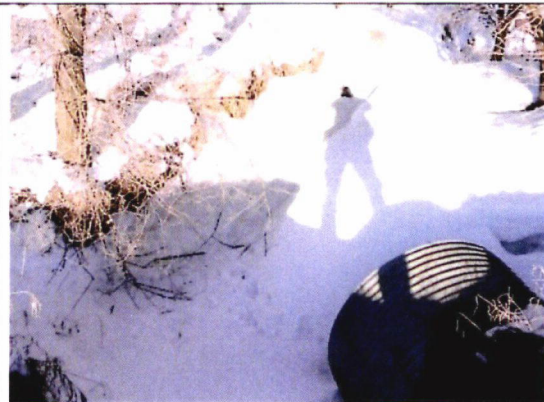
**STOP 2 – North of the Intersection of
COUNTY ROADS 6 & F – 0845 hrs.**

No apparent contamination; same as
described by Greg Michl 2-18-21.

Photo looking west.

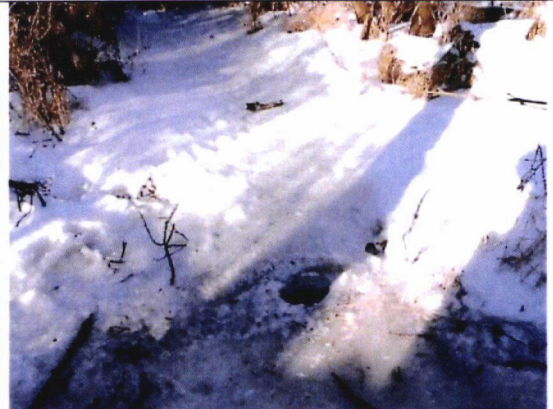
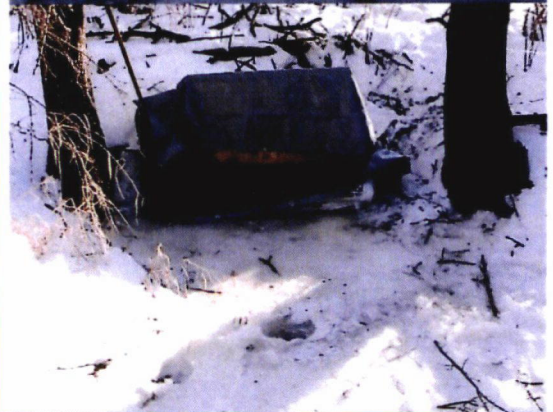
STOP 3 – Road 7/Highway 66 – 0850 hrs.

Same as reported by Greg Michl 2/18/21, no contamination apparent.

Top photo looking west.

Bottom photo looking east at containment structure.

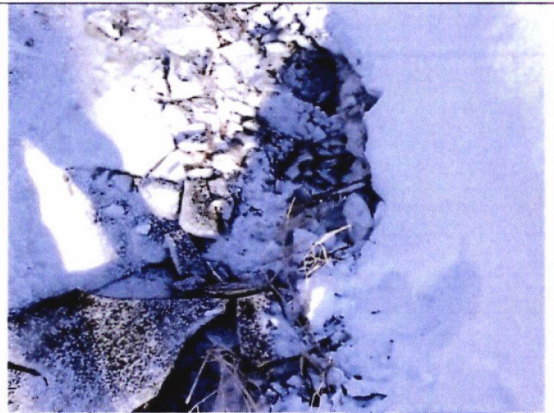
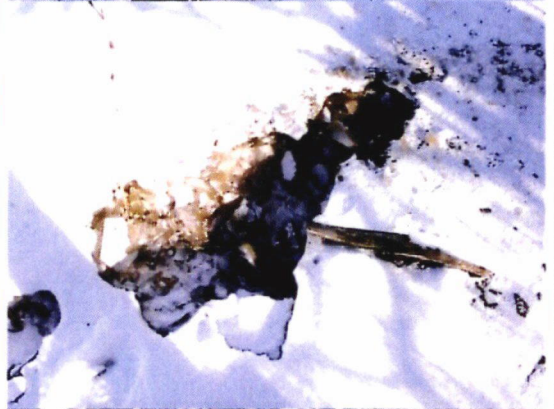
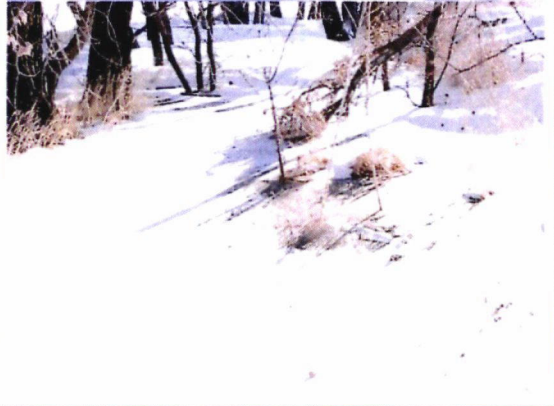
Top two photos looking down at frozen contamination on west side of county road.

Bottom photo looking east from east side of county road.

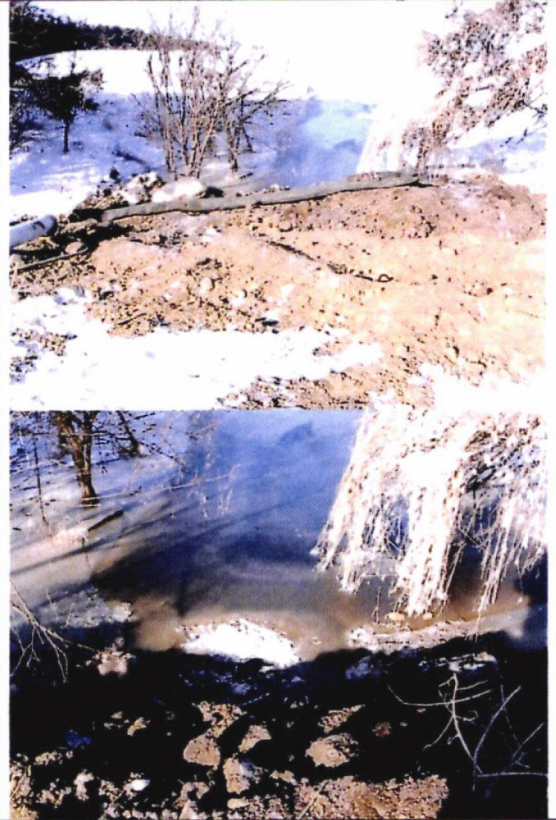
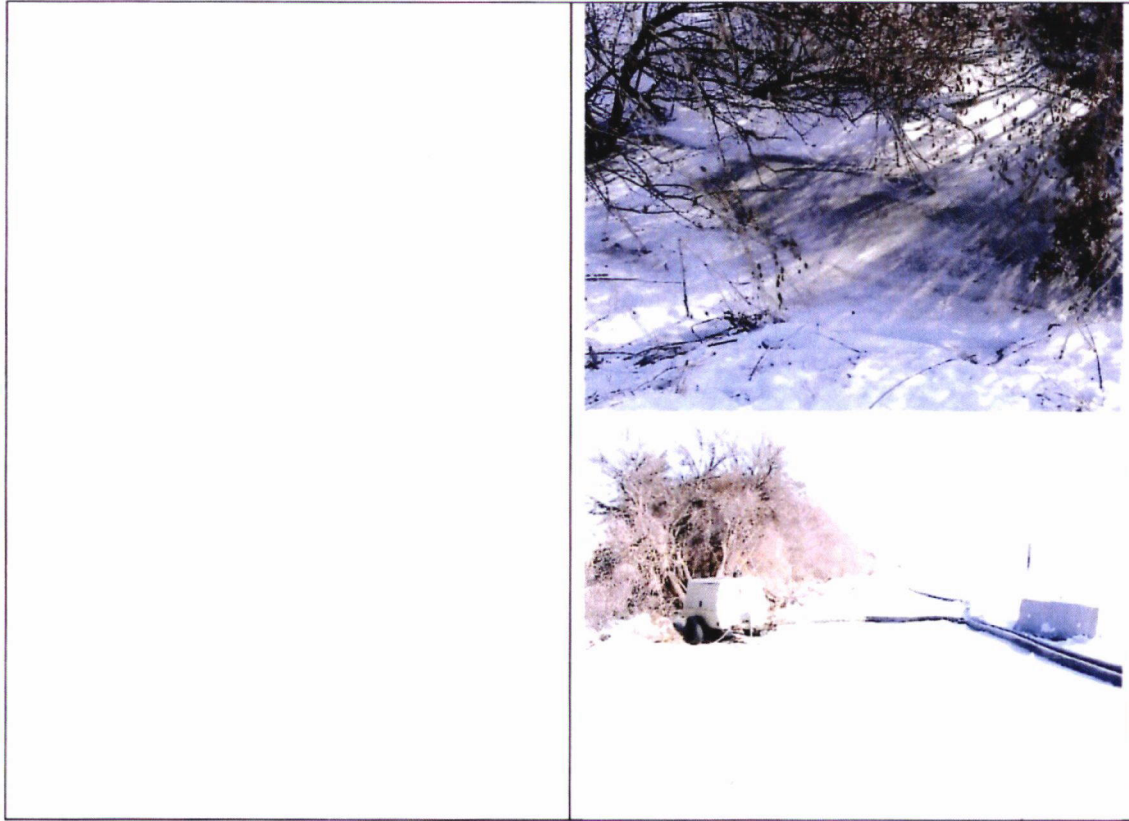
**STOP 5 – UN-L Eastern Extension – North
of County Roads 9 & J – 0915 hrs.**

Generator and piping present, but no pumping going on.

Top photo (page 5). Looking east at frozen contamination.

Bottom photo (page 5). Looking north at overview of generator (not operating) and piping.

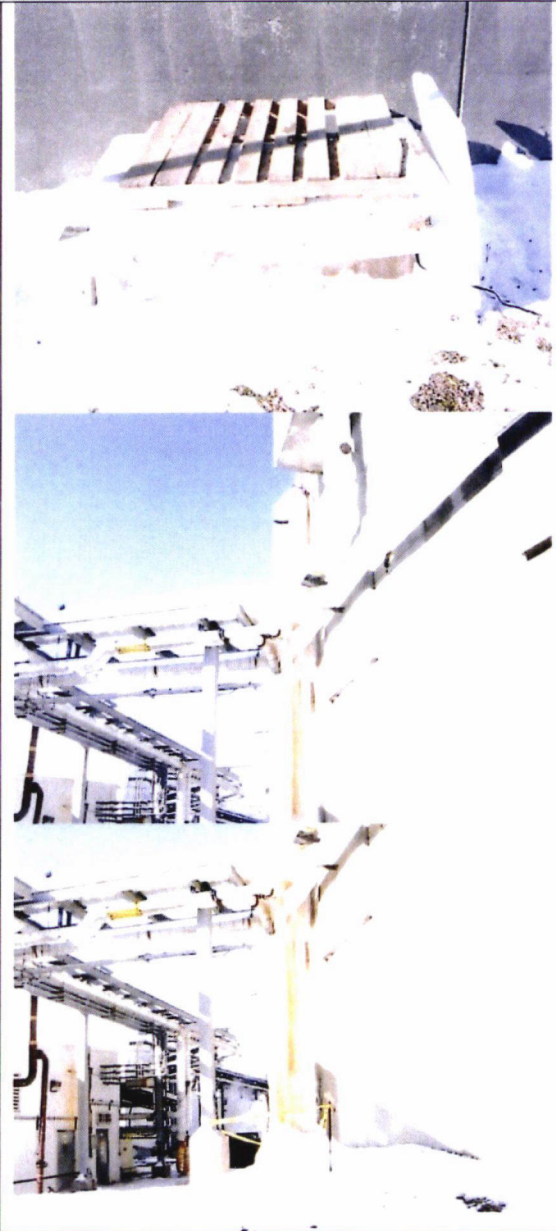
**STOP 6 – ALTEN LLC FACILITY
DIGESTERS – 0932 hrs.**

Top photo. Looking at piping well associated with north digester. Chord on right side leading into well is associated with heating lamp for piping.

Bottom two photos. Looking at ice accumulation on side of north digester.

AltEn added additional insulation along with an external heat source around the pipe on the second (north) digester. If material from the second (north) digester were to be discharged, efforts similar to what was performed with the first (south) digester spill would be made to contain the spill on AltEn's property. Given the fact no secondary containment is able to be constructed, AltEn believes it should drain the second (north) digester into its lagoon system in order to best protect the environment from any additional accidental leaks or spills and with NDEE's approval, would do so. With the plant shut down and thus no heat source for the digesters, the draining of the liquids from the digester will eliminate the risk of future freeze related pipe breaks and leaks from the digester.

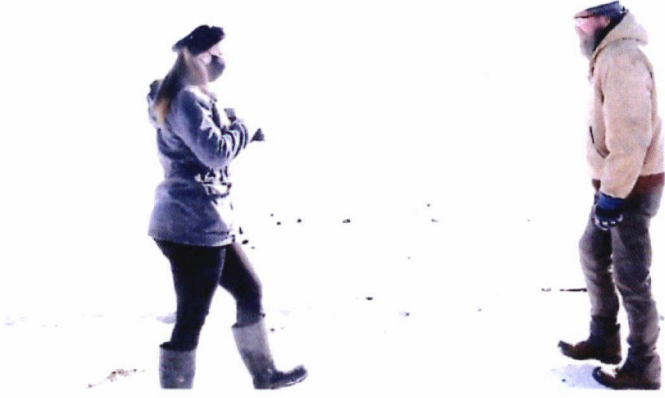
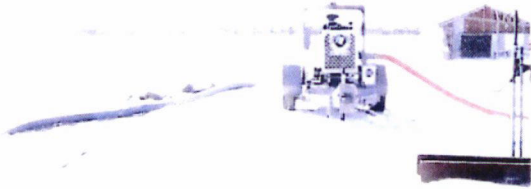
Facility pumping water from emergency lagoon to active wastewater lagoons in preparation for pumping material from north digester. NDEE Inspector Hillary Stoll on-site for inspection of emergency lagoon (see Photos below). Top photo looking east across "emergency lagoon." Bottom photo (looking south) shows water from "emergency lagoon" being pumped north to site wastewater lagoons.
