BEFORE THE NEBRASKA DEPARTMENT OF ENVIRONMENT AND ENERGY

IN THE MATTER OF)	
AltEn, LLC,)	CASE NO. 3546
)	
FID # 84069)	EMERGENCY COMPLAINT
)	AND ORDER
Respondent.)

ATTACHMENT I Photographs

Release of Thin Stillage and Cattle Manure from Digester at AltEn LLC, IIS #84069, RA
#021221-NH-0845

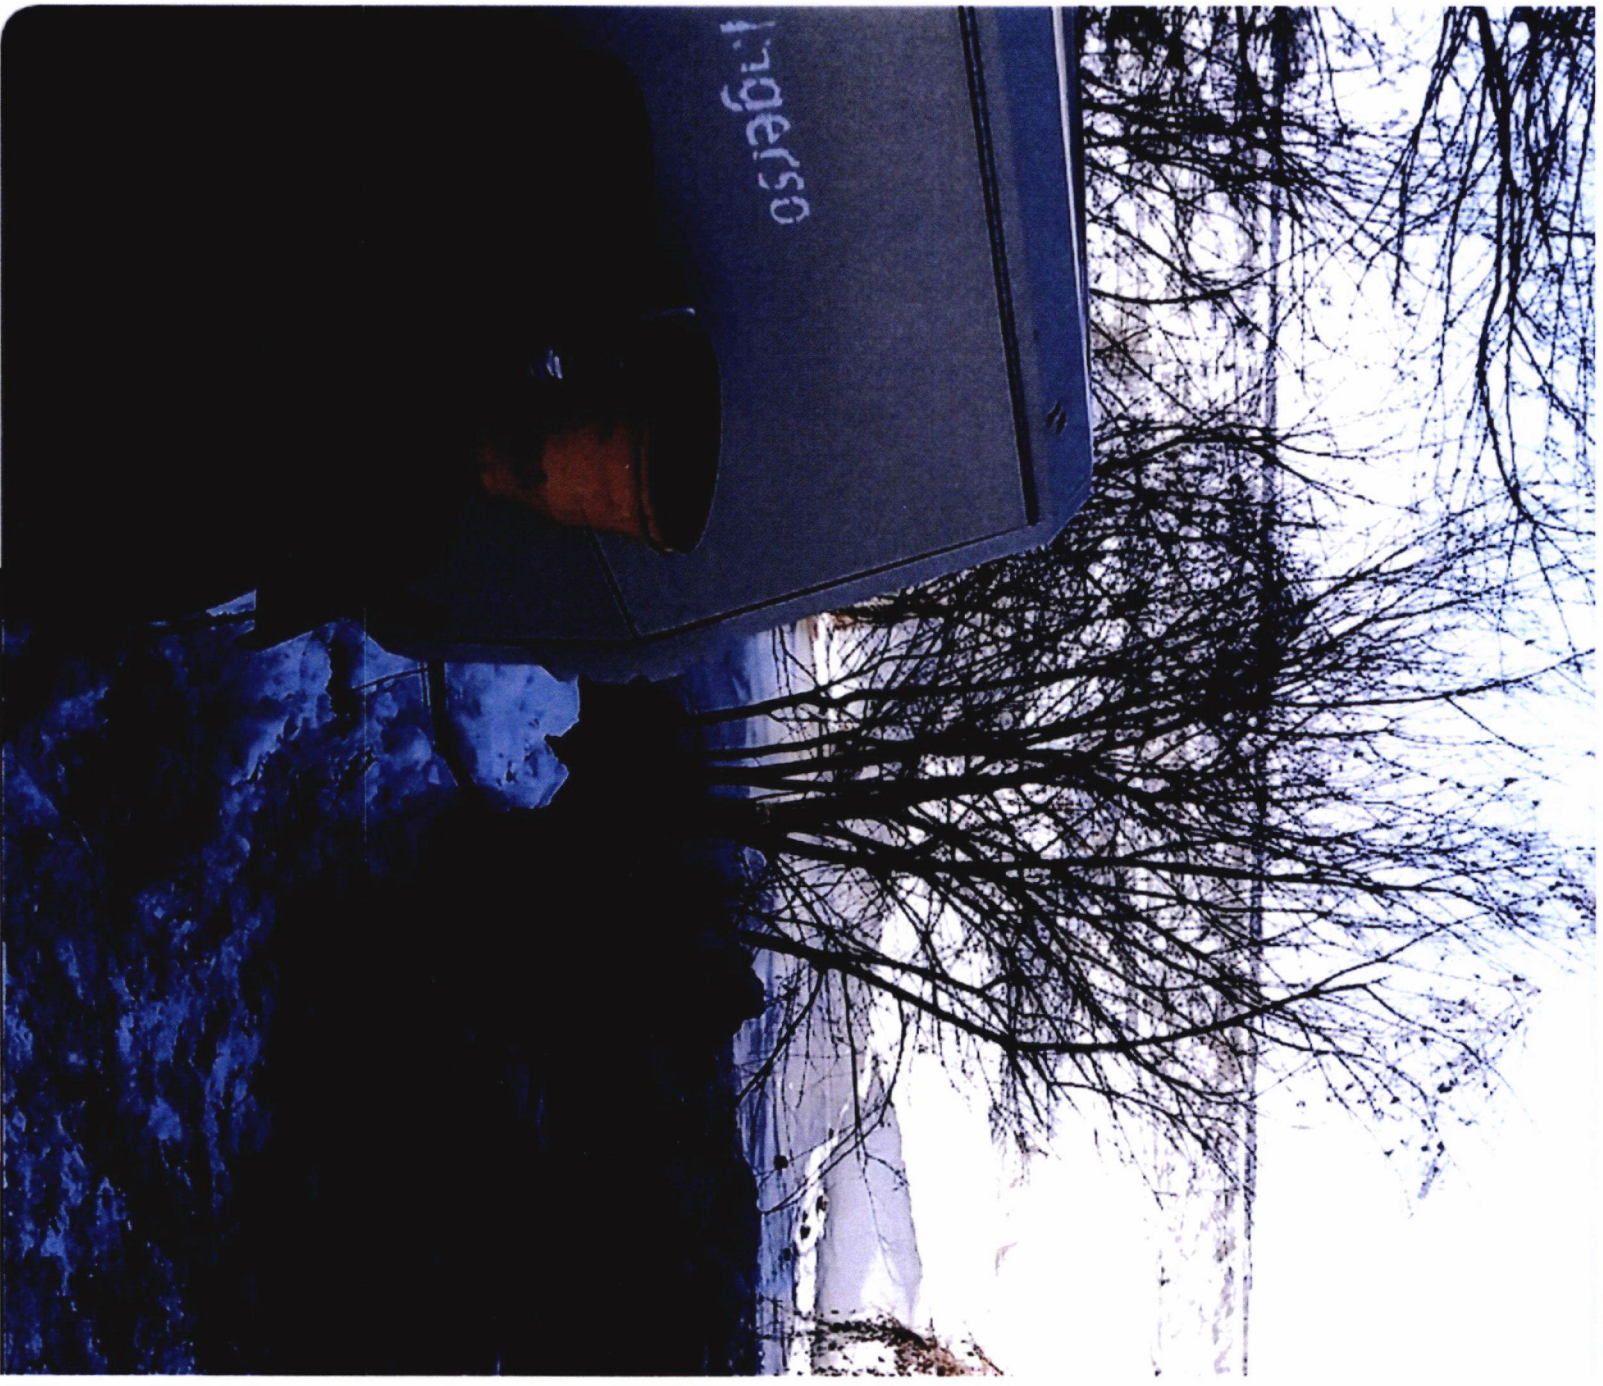
I read your site visit published on the NDEE website today.
I was also examining the spill yesterday and took the photograph below where AltEn's contractor was pumping the spillage from Johnson Creek back to the lagoon from the intersection of county roads 9 and J.
